# REPORT ON LOAD TESTS ON RVK 100 - UNITS

Hønefoss, April 1998.

# REPORT FROM TESTS OF RVK-UNITS

# REPORT ON LOAD TESTS ON RVK 40 - UNITS

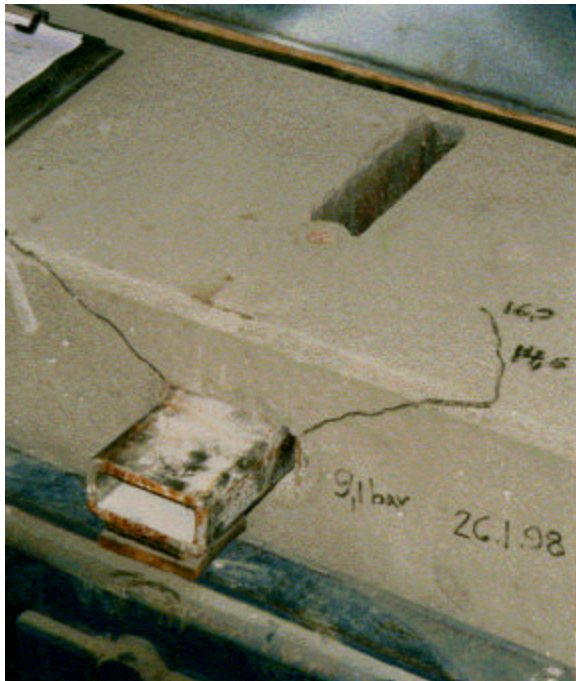
Picture 7. Test A4 at 80 kN.

Gage reading	Load per RVK-unit	Observations	Reference
9,1	46,9	Small cracks extending from the top corners of the RVK.	
12,3	60,4	Small increase in crack width, cracks start to extend on the top surface.	
16,9	79,7	No significant changes.	Picture 7
23,0	105,3	Left at this load level for about three minutes, nothing happened.	Picture 8
23,9	109,1	Failure.	Picture 9

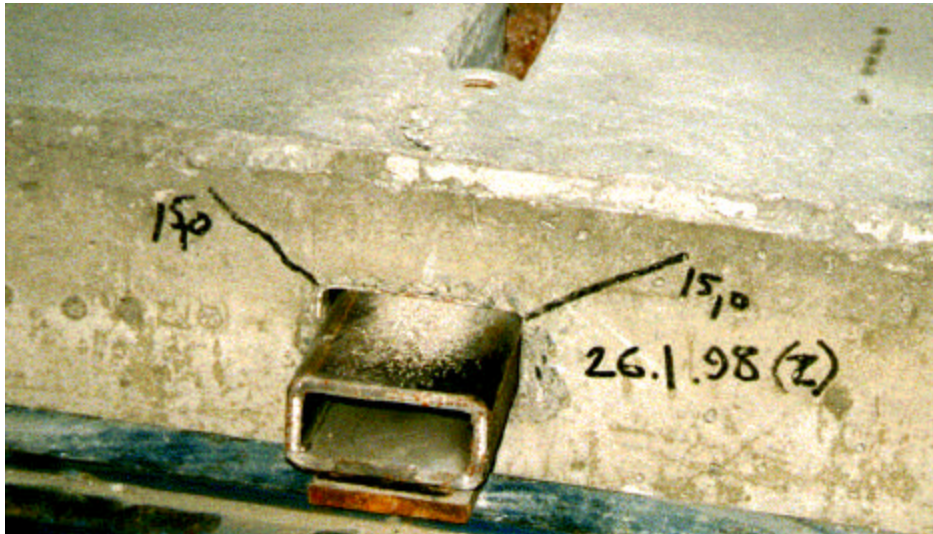
Picture 10. Test A5 at 72 kN.

Gage reading	Load per RVK-unit	Observations	Reference
9,0	46,5	Small cracks extending from the top corners of the RVK.	
11,0	54,9	Small increase in crack width, but not much in crack length.	
15,0	71,7	Small increase in crack width, but not much in crack length.	Picture 10
18,0	84,3	Increase in crack width, cracks no extending on the top surface.	
20,5	94,8	Cracks developed from the bottom corners of the RVK, failure.

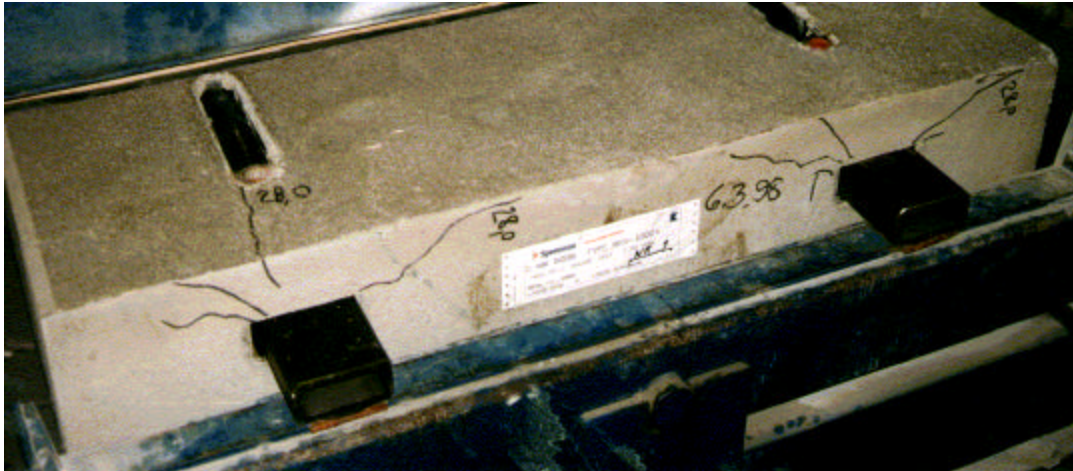
Picture 12. Test B2 at 63 kN.

Gage reading	Load per RVK-unit	Observations	Reference
14,0	33,7	Start of crack development.	
28,0	63,1	Crack above one of the RVK's.	Picture 12
33,0	73,6	Insignificant increase of the cracks.	
38,0	84,1	Significant increase of the cracks.	Picture 13
43,0	94,6	The top layer of concrete starts to lift at one side. Increase in crack width, but not much in crack length.	
46,9	102,8	Failure.

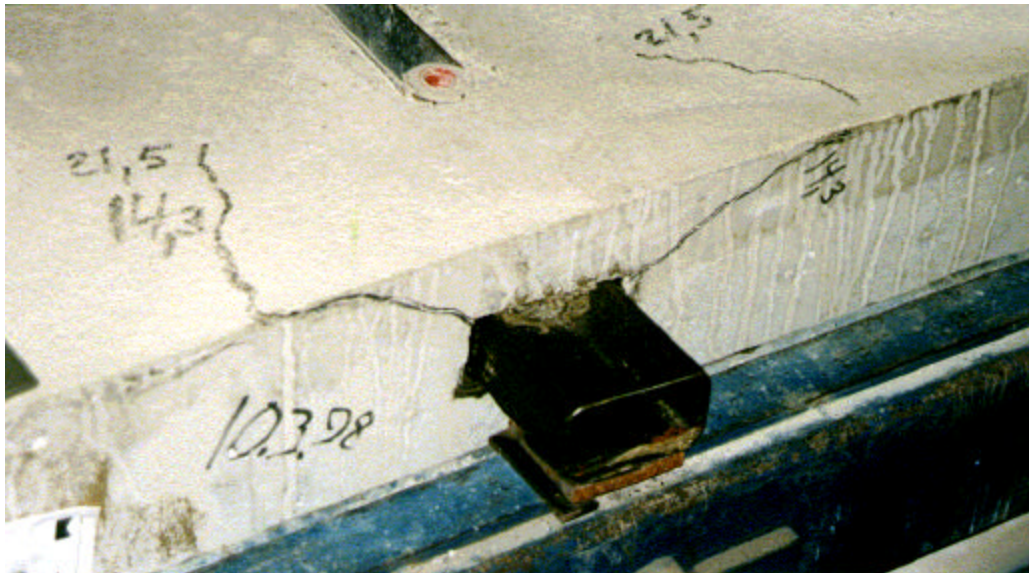
Picture 18. Test C1 at 102 kN. Notice shims at the support.

Gage reading	Load per RVK-unit	Observations	Reference
14,4	72,0	Cracks had developed from the top corners of the RVK. On one side the cracks extended in on the top surface.	
16,5	80,8	Insignificant crack increase.	
19,0	91,3	Insignificant crack increase.	
21,5	101,8	Cracks extending on the top surface on both sides.	Picture 18
34,3	155,6	Lifting of the top layer of concrete, failure.

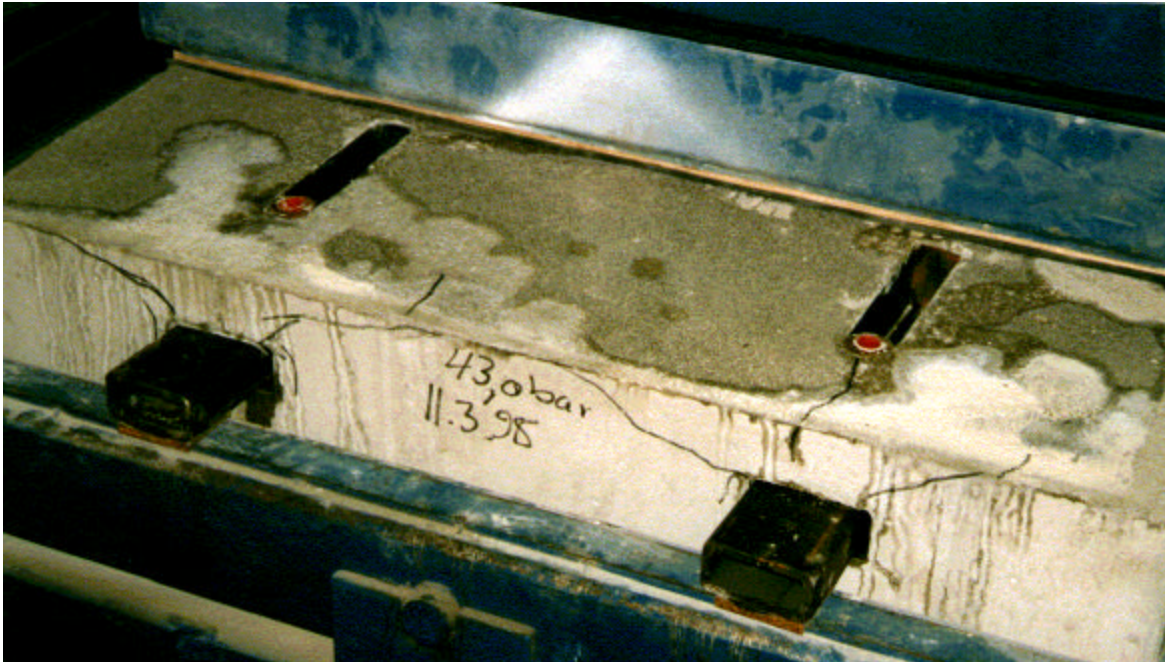
Picture 23. Test C4 at 96 kN.

Gage reading	Load per RVK-unit	Observations	Reference
18,8	45,2	Start of crack development at one of the RVK's,	
26,4	61,2	Crack development directly above the other RVK.	
34,0	77,2	Crack width 0,8 mm on one side and 0,3 mm on the other.	
38,4	86,4	Slight crack increase.	
43,0	96,1	Crack width increased to 1,5 mm on one side and 0,8 mm on the other.	Picture 23
61,5	134,9	Failure.	Picture 24

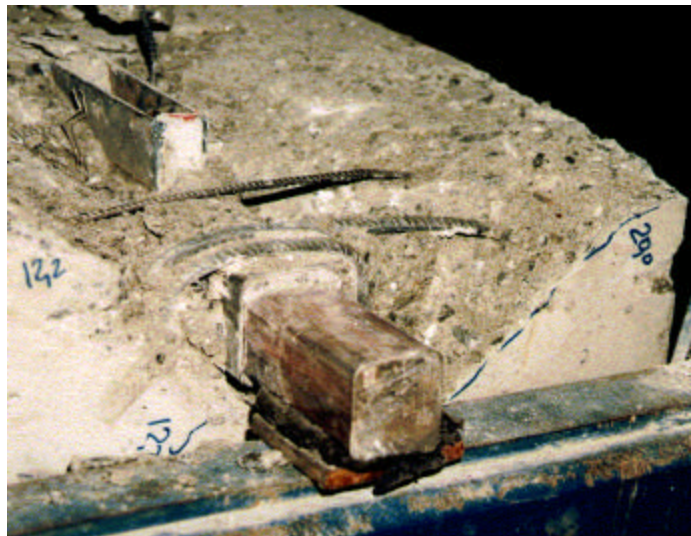
Picture 5. The right unit in test D2 when the test was discontinued and the debris removed.

Gage reading (bar)	Load per RVK unit (kN)	Observations	Reference
5,4	14,6	Cracks of width about 0,7 at the front surface above the right unit, otherwise as for the first stage of test D1.	Figure 4
12,2	28,9	Small cracks (0,2 mm) had developed on the front surface by the left unit, increased crack width (2,8 mm) for the right unit. No visible cracks on the top surface.	
16,0	36,9	Cracks visible on the top surface by the right unit.	
20,0	45,3	The concrete above the unit on the right side had lifted 4 mm, on the left side 3 mm.	
22,5	50,6	A crack (0,2 mm) developed at the front surface by the left unit, extending left and downward from the lower left hand corner of the unit.	
32,2	70,9	The concrete above the right unit had lifted about 10 mm.	
		Continued running the hydraulic pump – the deformations increased with negligible increase in the pressure. Ran the pump until the jacks were extended to their maximum. The damage was severe, but the load carrying capacity was still intact.	Picture 5

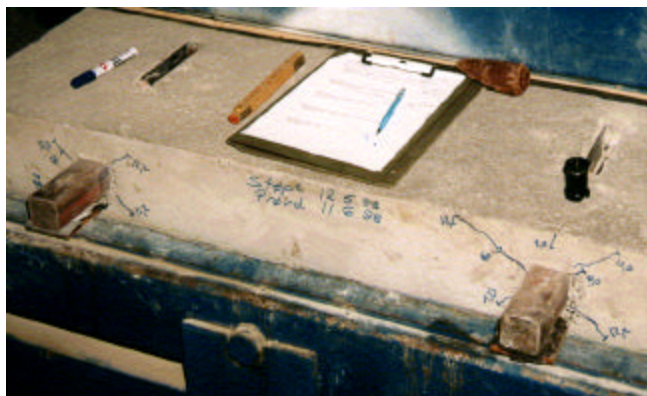
Picture 8. Test D4 at 28,9 kN.

Gage reading (bar)	Load per RVK unit (kN)	Observations	Reference
0	0	Small cracks (0,3 mm) were visible at the front surface, extending downward at about 45 ° from the lower corners of both units.	Figure 5
2,9	9,4	A small vertical crack developed on the front surface directly above the right unit. The crack was not visible on the top surface.	Picture 8
6,0	15,9	Small cracks.	
12,2	28,9	Increased crack lengths, insignificant increase of crack width.	Picture 8
14,3	33,3	Crack width at the front surface increased to 4 mm on the left side of the left unit. All other crack widths less than 1 mm.	
20,0	45,3	Crack width at the front surface increased to 8 mm on the left side of the left unit. All other crack widths practically unchanged. The vertical crack at the front surface above the right unit now became visible at the top surface.	Picture 9
26,3	58,5	Insignificant changes in the cracks.	
32,7	72,0	Failure load.
