**VIRGINIA POLYTECHNIC INSTITUTE
AND STATE UNIVERSITY**

**TESTS OF THE JVI SHOOTER IN
DOUBLE-TEE BEAMS**

February 2009

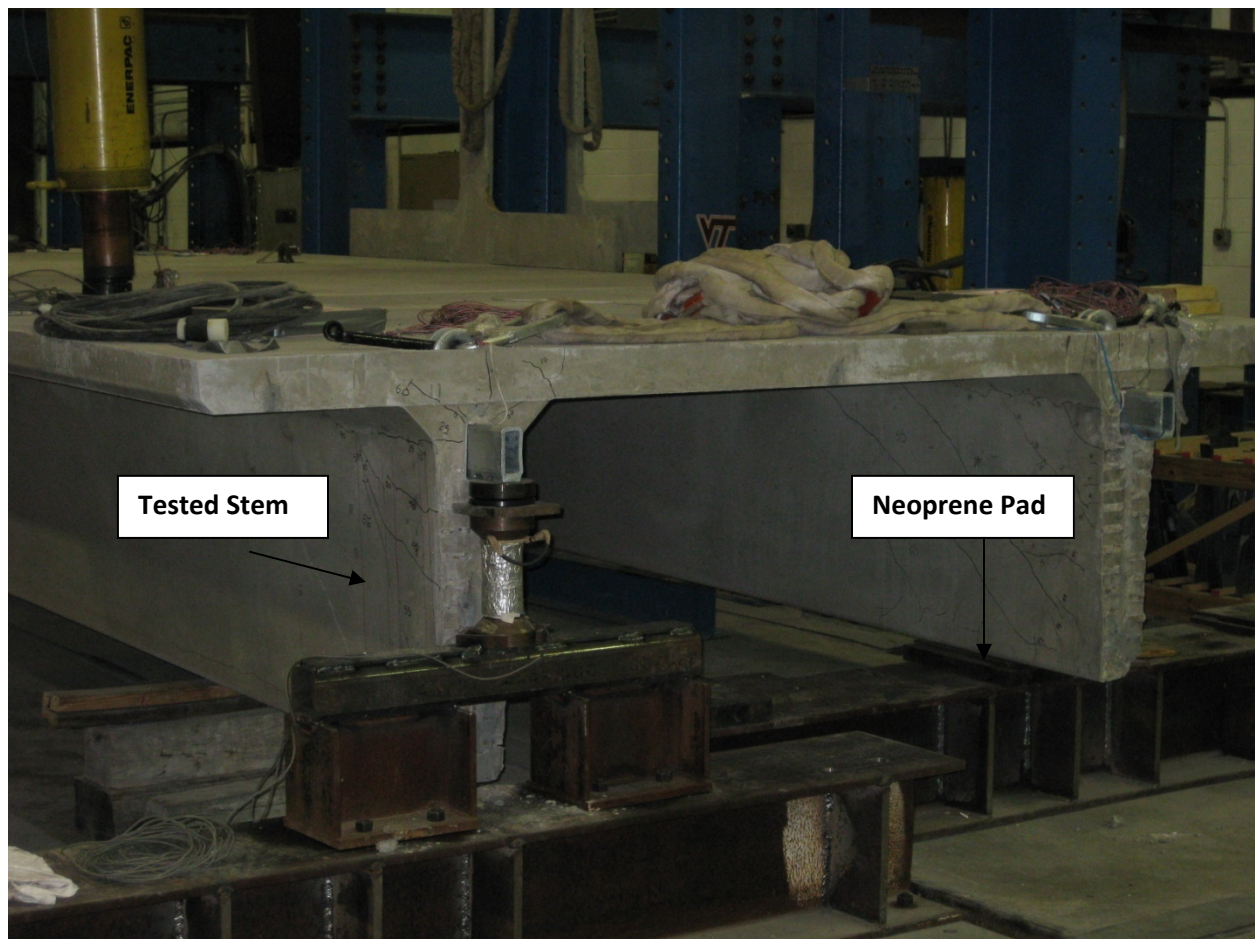
Figure 1: Test Set-up

The double-tee was set up such that three stems were supported on neoprene pads, and the tested stem was supported by the shooter. An actuator was placed 6 ft away from the face of the double-tee, using a load cell to measure the force applied to the beam. Another load cell was placed under the extended arm of the shooter to measure the force carried by the connection. There were also three wire pots set up to measure deflections of the beam. One wire pot was set up under the applied load while two others were set up near the face of the double-tee, one under the stem and the other on the flange of the beam. This was done to make sure there was no separation between the connection and the concrete during testing. Prior to casting of the double-tee, strain gages were placed on the rebar cages to determine how the bars were being engaged during testing.

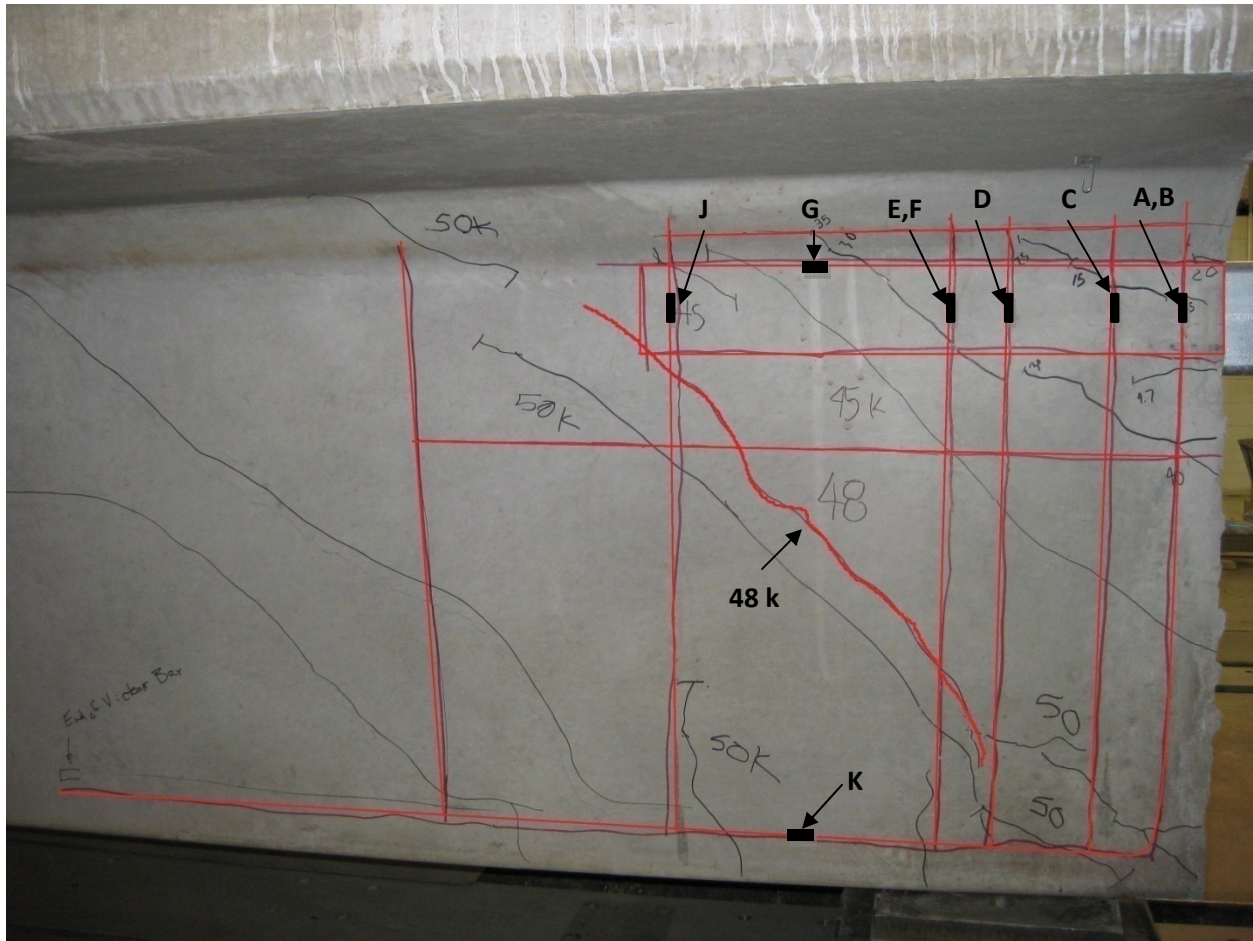
Figure 7: N50 test

The first test performed was on the Norway 50 kip Shooter. All instrumentation was zeroed while the shooter was not resting on the beam. This was done to determine the self weight that was carried by the shooter. Loading proceeded until 15 kips was registered in the load cell under the shooter, followed by additional increments of 5 kips until failure. After each increment of loading cracks were marked and then monitored to see how much, if any, they opened. This shooter failed at 50.3 kips. On the way to failure, a large crack occurred at 48 kips. This crack was a good indication that failure was near.

The strain in the rebar was measured at several locations labeled with letters A thru K in Figure 7. Figure 8 shows the relationship between the load in the shooter and the strain in each gage. The graph indicates that gages closer to the double-tee end experienced higher strains during testing. This graph shows that the bars farther from the face of the double-tee also experience some tension during the early loading stages. The lower Victor bars, gage K, are not engaged until the concrete cracks across the bar at 48 kips. The Victor bars are the longitudinal bars at the bottom of the rebar cage. The bar sizes and layout are presented in the shop drawings provided by Unistress located in Appendix A.

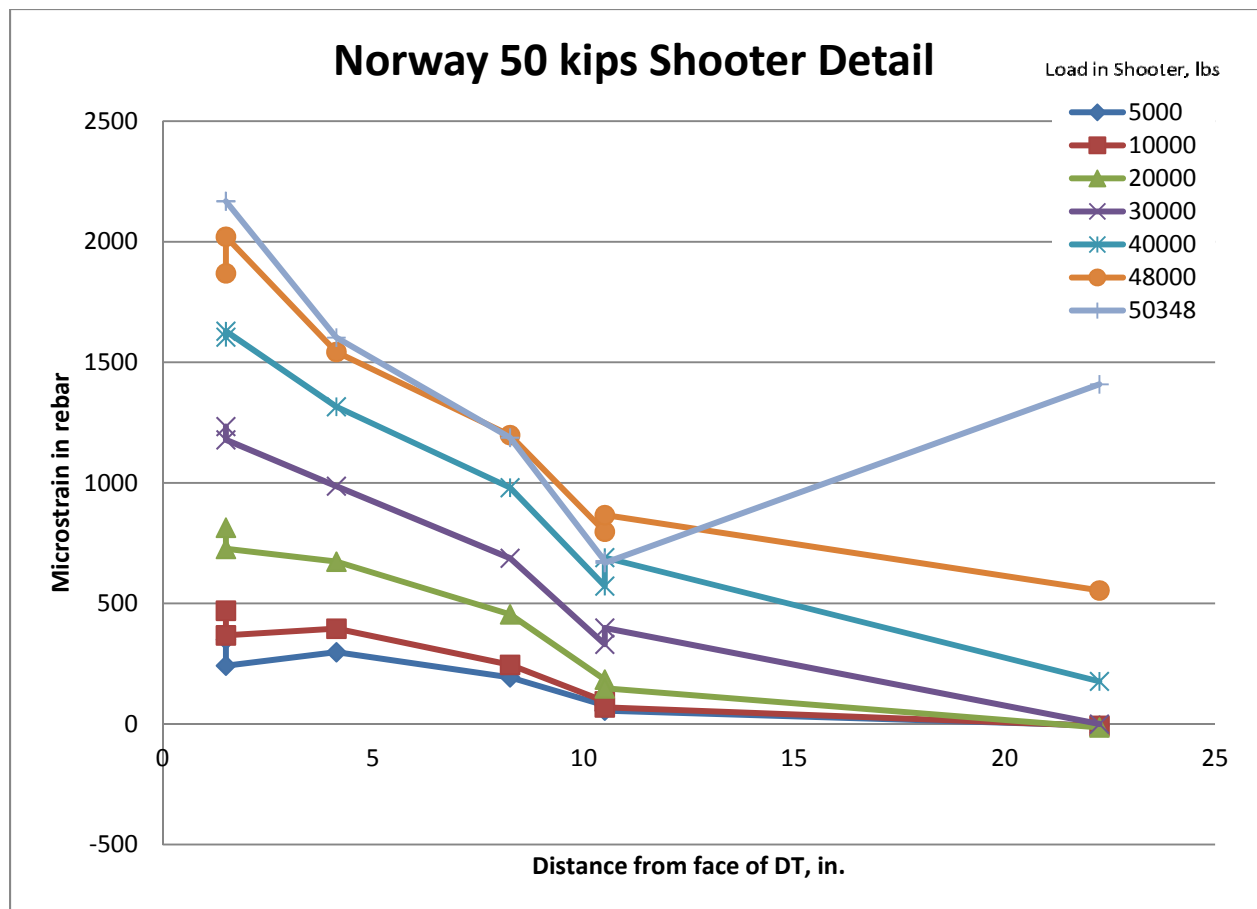
Figure 9: Microstrain in rebar vs. Distance from face of the double-tee for N50 Test

The next graphs plot the strain in the rebar versus the distance from the face of the double-tee, the force in the front bars versus the load in the shooter, and the displacements of the three wire pots versus the load in the shooter. Figure 9 indicates that as the distance from the face of the double-tee increases, the strain in each gage decreases approximately linearly at each load step represented. Figure 10 indicates that the force resisted by the shooter is linearly related to the force in the first four bars of the cage. In previous calculations using a strut-and-tie model to determine the amount of reinforcing, it was estimated that the force in this region would be lower. This indicates that the model requires adjustment. In Figure 11 the displacements plotted for the three different wire pots are similar and can be considered equivalent. This indicates that the displacement of the beam is small, and there is no separation between the shooter and the concrete.

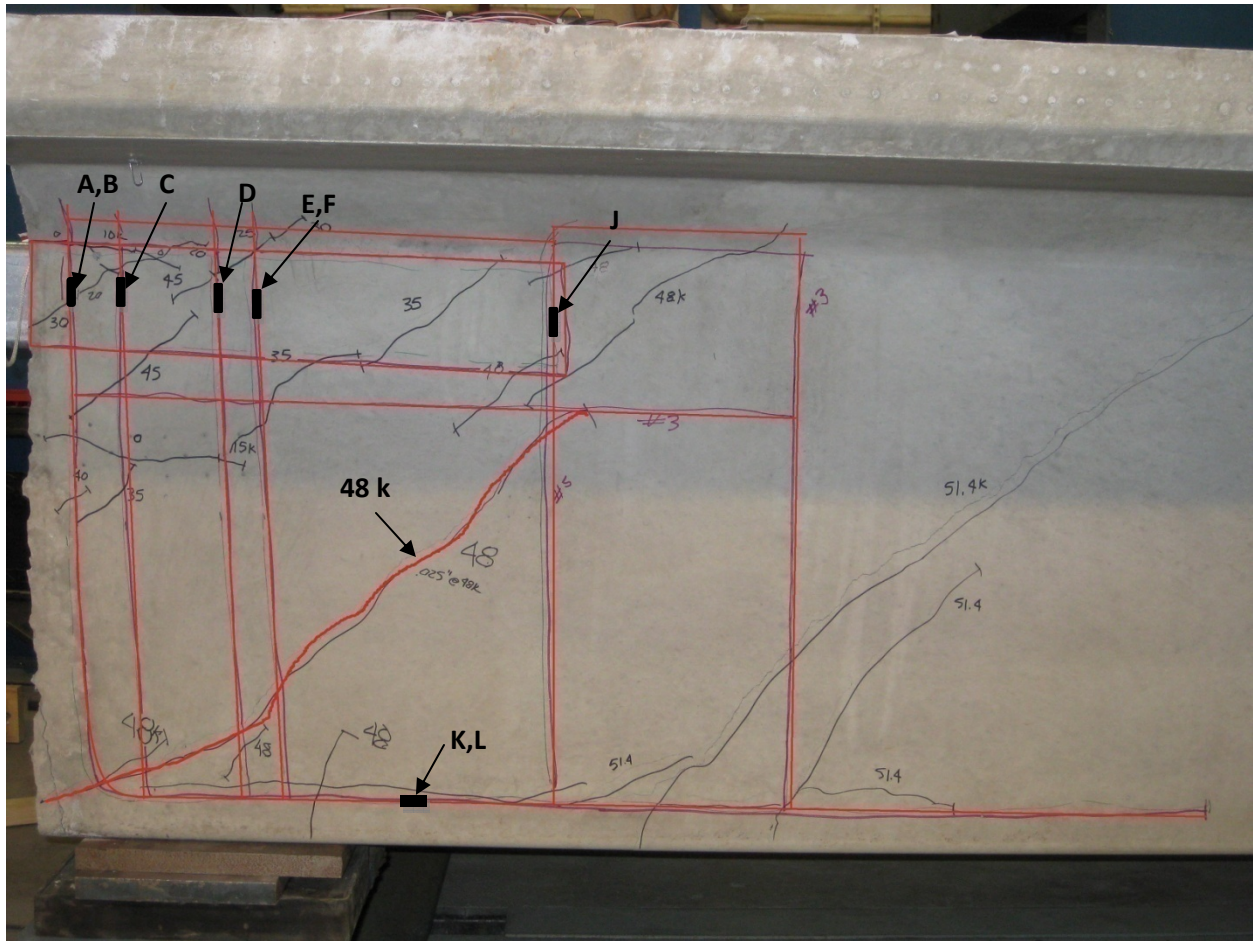
Figure 12: J50 Test

The next test performed was on the Jason 50 kip Shooter. All instrumentation was zeroed while the shooter was not resting on the beam, as previously done. Loading proceeded until 10 kips was registered in the load cell under shooter, followed by additional increments of 5 kips until failure. After each increment of loading cracks were marked and then monitored to see how much, if any, they opened. This shooter failed at 51.4 kips. The warning crack at 48 kips occurred in this test as well, indicating that failure was near.

The gages that measured strain for this test are labeled with letters A thru L in Figure 12. Figure 13 shows the relationship between the load in the shooter and the strain in each gage. Once again the graph indicates that gages closer to the double-tee end experienced higher strains during testing and the bars farther from the face of the double-tee experience some tension at lower loads. The lower Victor bars, gages K and L, are not engaged until the concrete cracks across the bar the 48 kip warning load. The bar sizes and layout are presented in the shop drawings provided by Unistress located in Appendix A.

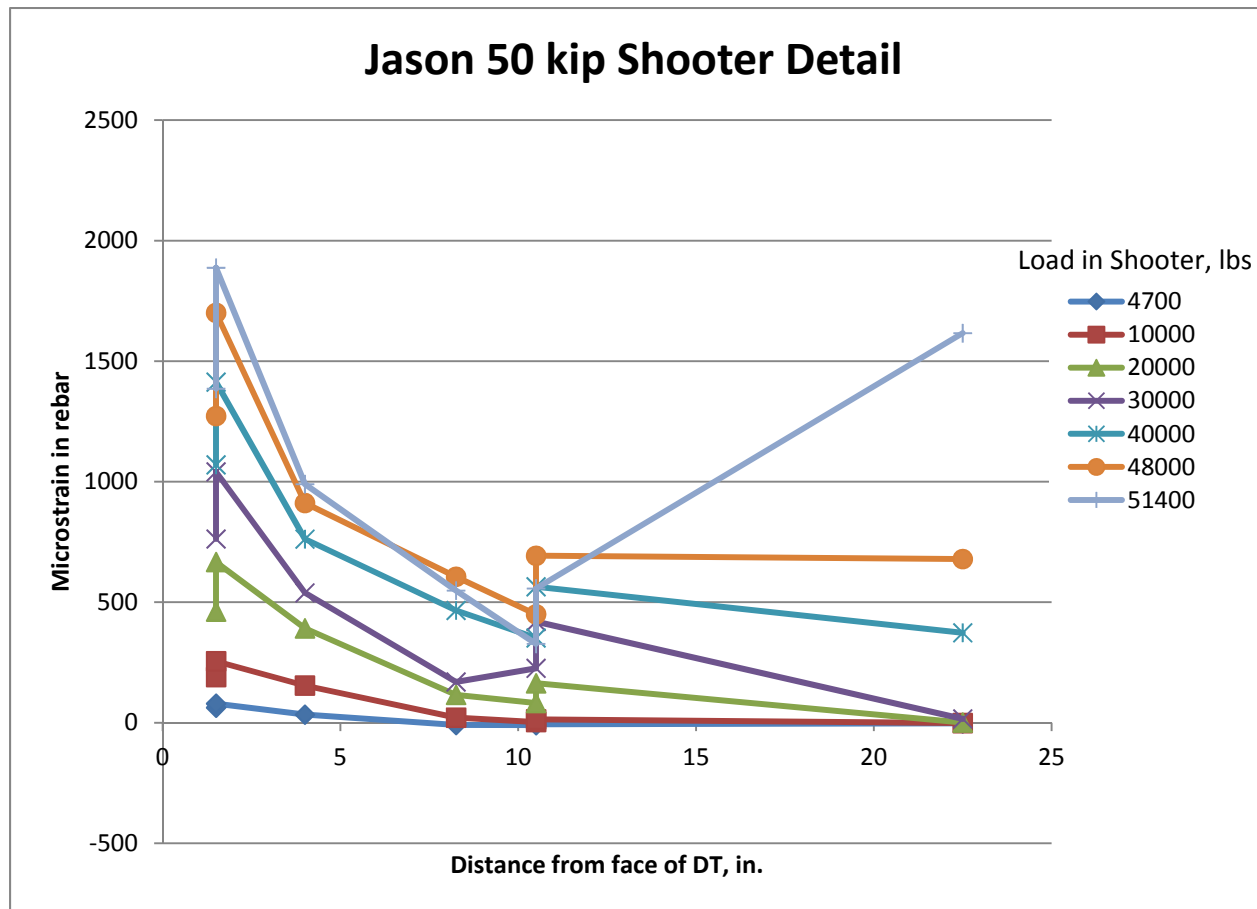
Figure 14: Microstrain in rebar vs. Distance from face of the double-tee for J50 Test

The next graphs plot the strain in the rebar versus the distance from the face of the double-tee, the force in the front bars versus the load in the shooter, and the displacements of the three wire pots versus the load in the shooter. Figure 14 indicates that as the distance from the face of the double-tee increases, the strain in each gage decreases in a parabolic manner at each load step represented. Figure 15 indicates that the force resisted by the shooter is linearly related to the force in the first four bars of the cage. In previous calculations using a strut-and-tie model to determine the amount of reinforcing, it was estimated that the force in this region would be similar to the results obtained. Thus the reinforcing provided is sufficient to carry the load present in this region. In Figure 16 the displacements plotted for

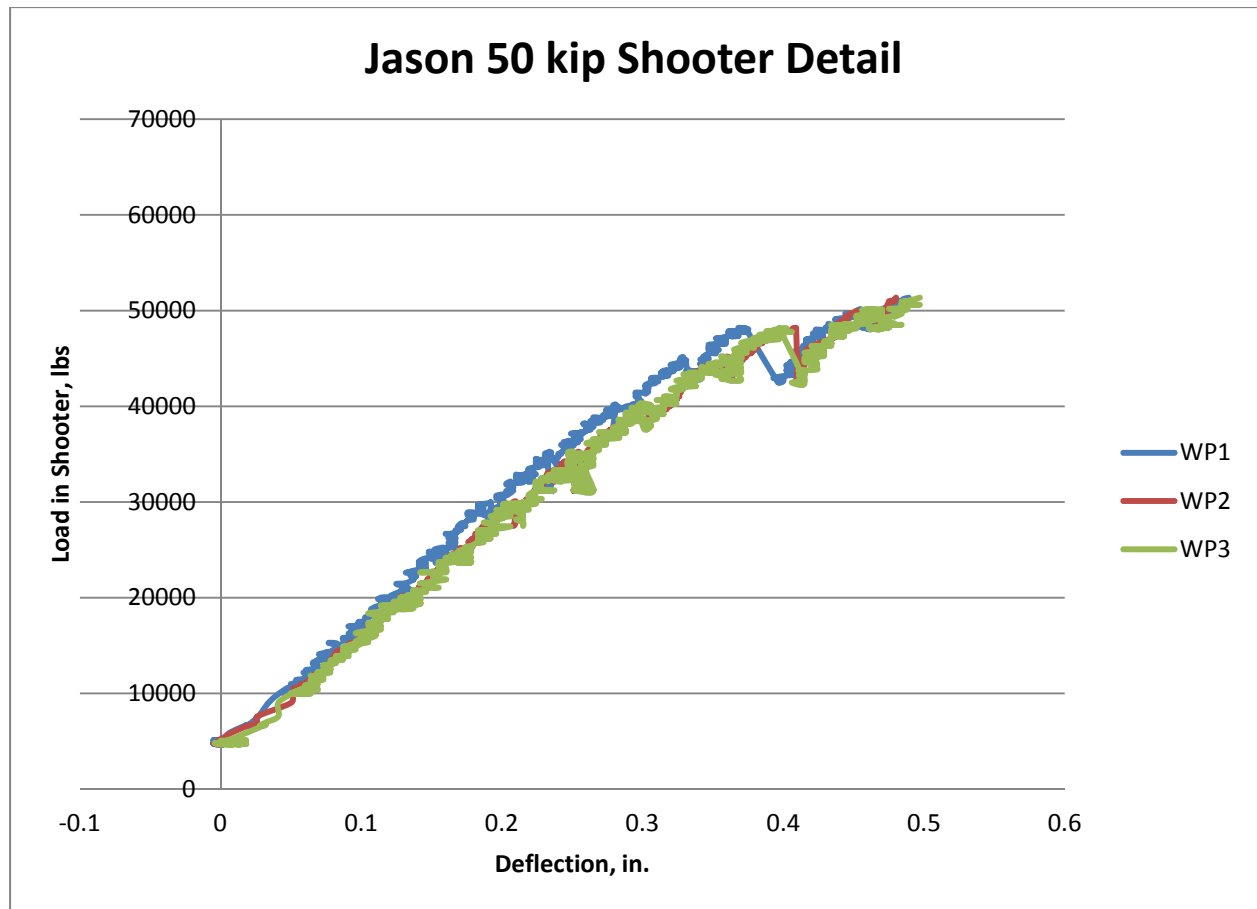
Figure 16: Load vs. Deflection for J50 Test

the three different wire pots are similar and can be considered equivalent. This indicates that the displacement of the beam is small, and there is no separation between the shooter and the concrete.

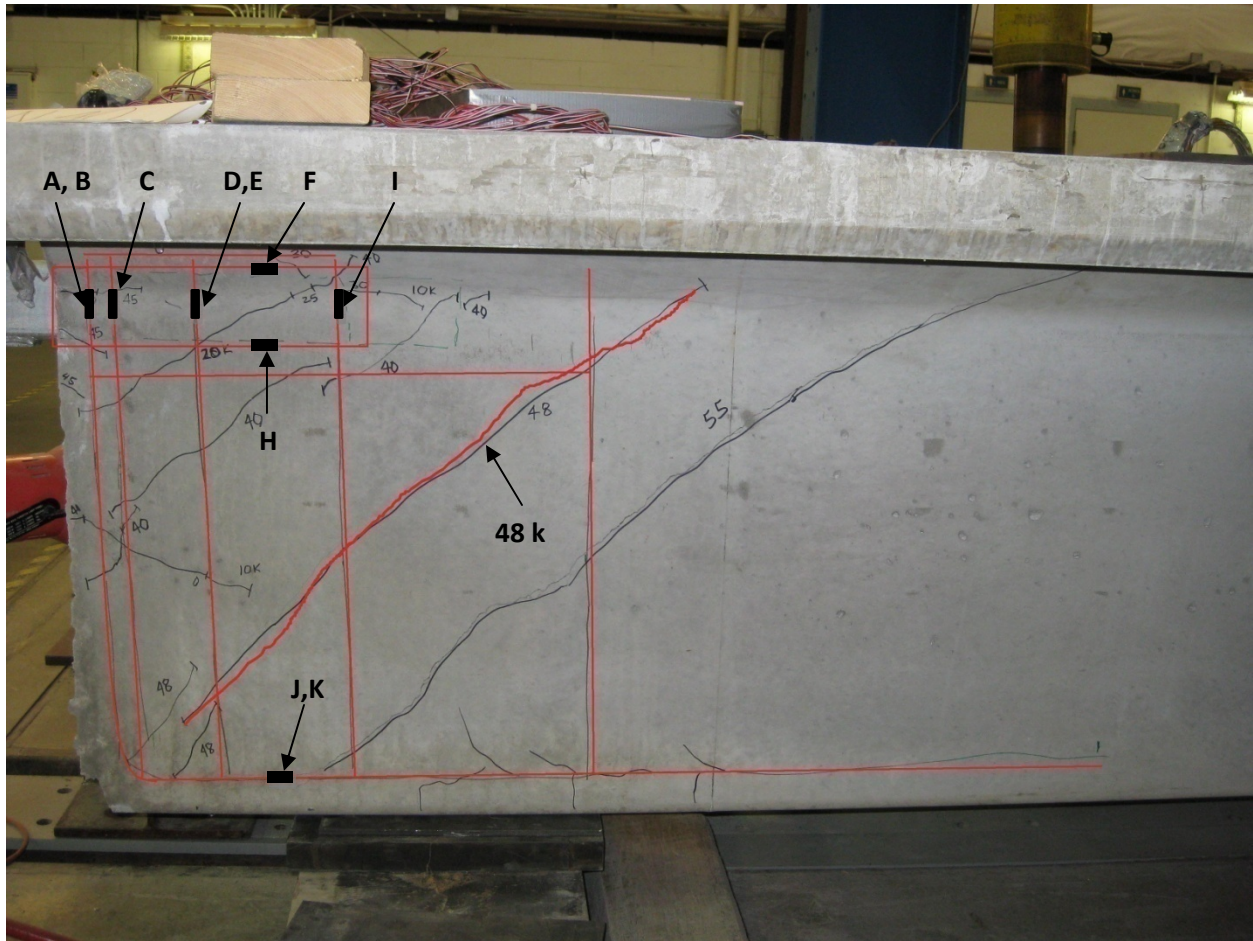
Figure 17: N40 Test

The next test performed was on the Norway 40 kip Shooter. All instrumentation was once again zeroed while the shooter was not resting on the beam. Loading proceeded until 10 kips was registered in the load cell under the shooter, followed by additional increments of 5 kips until failure. After each increment of loading cracks were marked and then monitored to see how much, if any, they opened. This shooter failed at 55.3 kips, exceeding both the Norway 50 kip shooter and the Jason 50 kip shooter. Just as in the previous two tests, the warning crack at 48 kips occurred indicating that failure was near.

The gages that measured strain for this test are labeled with letters A thru K in Figure 17. Figure 18 shows the relationship between the load in the shooter and the strain in each gage on the rebar and the relationship between the load in the shooter and the strain on the shooter itself. Once again the graphs indicate that gages closer to the double-tee end experienced higher strains during testing and the bars farther from the face of the double-tee experience some tension at lower loads. The lower Victor bars, gages K and J, are not engaged until the concrete cracks across the bar the 48 kip warning load. The bar sizes and layout are presented in the shop drawings provided by Unistress located in Appendix A.

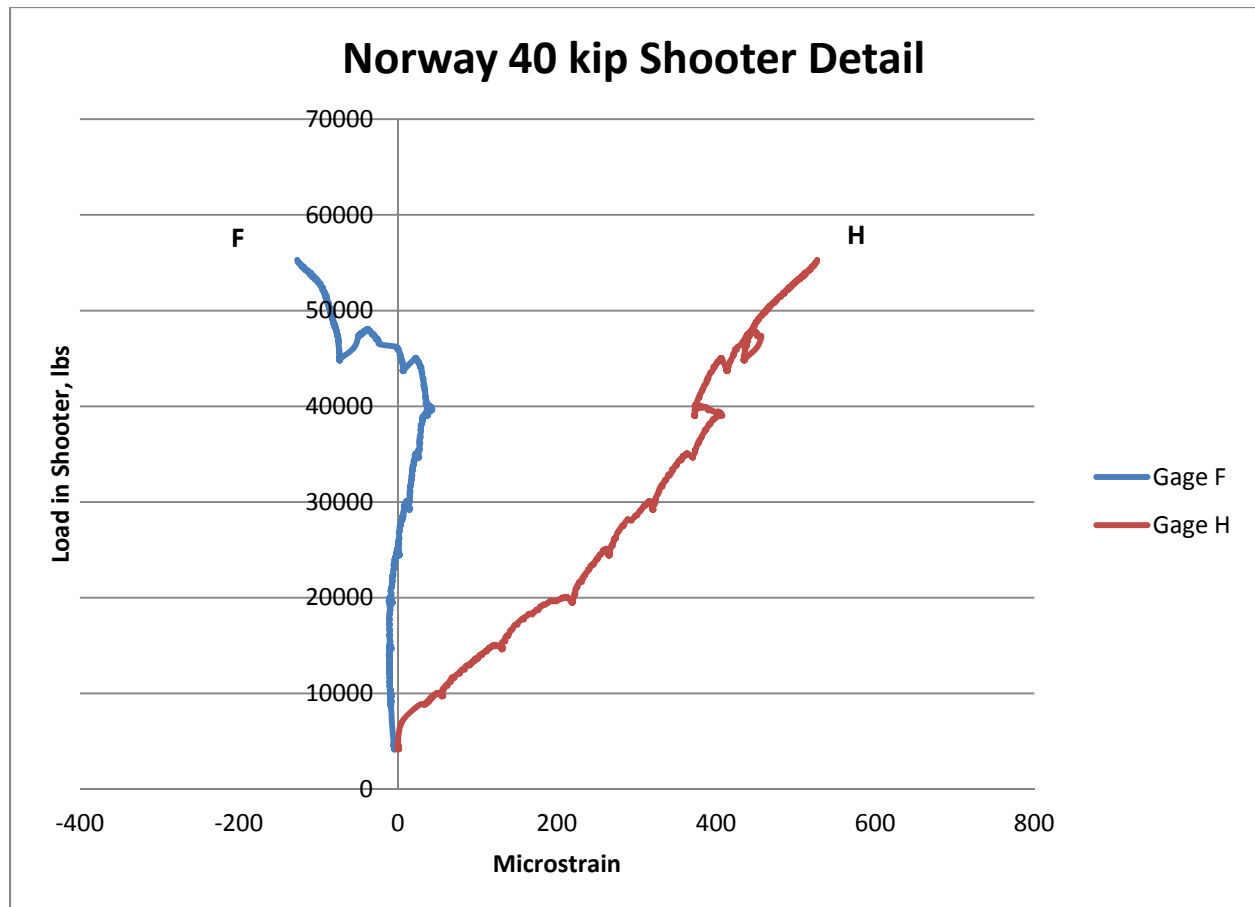
Figure 19: Load vs. Strain for gages on the Shooter in N40 Test

Figure 19 presents the strain measured by the gages adhered to the top and bottom of the outer tube of the shooter (gage H on bottom, gage F on top). As expected the bottom of the tube experiences tension. The strain in the top of the tube begins in compression, becomes tensile, and then returns to compression. Further analysis will be performed on the shooter itself. The other thing to note, however, is that the strains remain quite small at this location in the shooter (less than $600\mu\epsilon$).

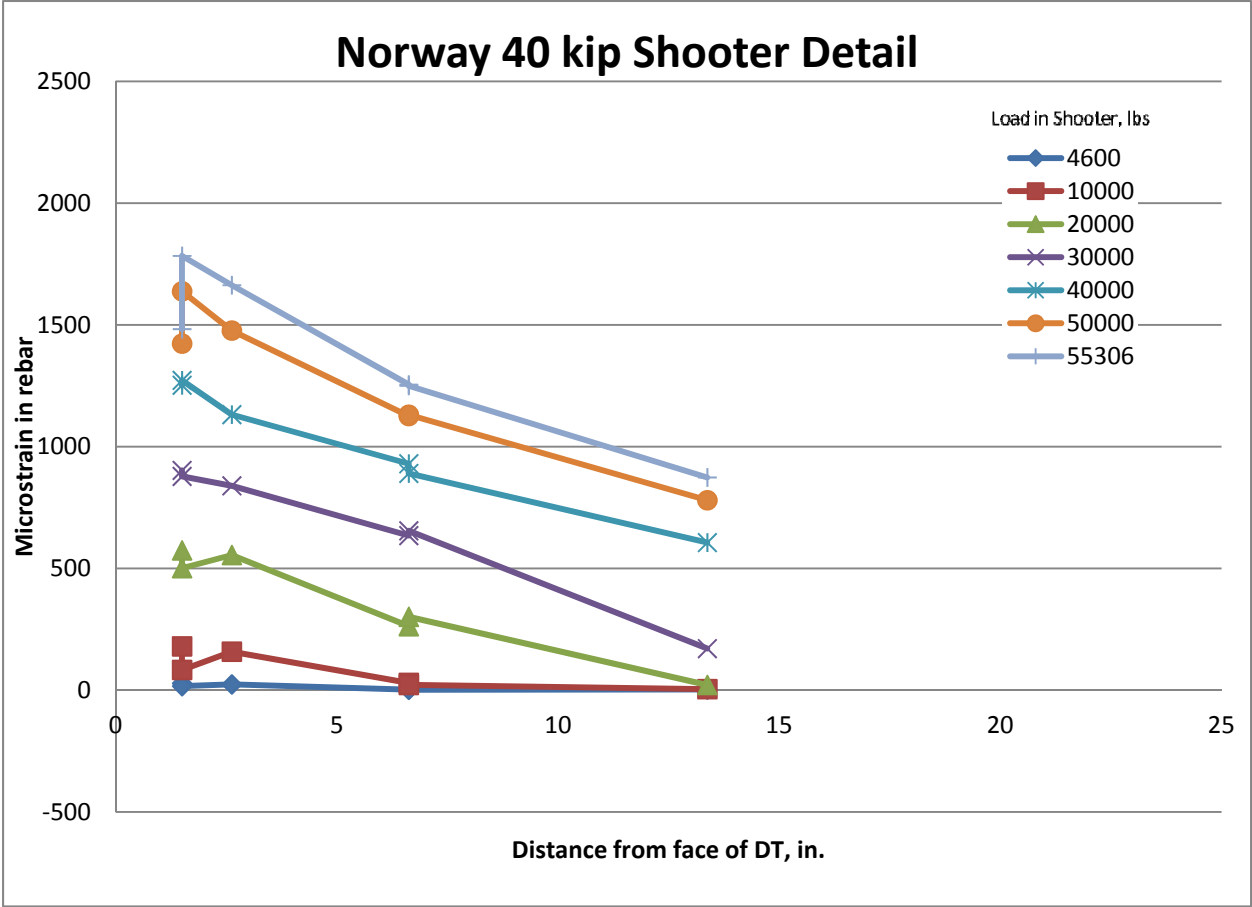
Figure 20: Microstrain in rebar vs. Distance from face of the double-tee for N40 Test

The next graphs plot the strain in the rebar versus the distance from the face of the double-tee, the force in the front bars versus the load in the shooter, and the displacements of the three wire pots versus the load in the shooter. Figure 20 indicates that as the distance from the face of the double-tee increases, the strain in each gage decreases in a linear manner at each load step represented. Figure 21 indicates that the force resisted by the shooter is linearly related to the force in the first four bars of the cage. In previous calculations using a strut-and-tie model to determine the amount of reinforcing, it was estimated that the force in this region would be similar to the results obtained. Thus the reinforcing provided is sufficient to carry the load present in this region. In Figure 22 the displacements plotted for

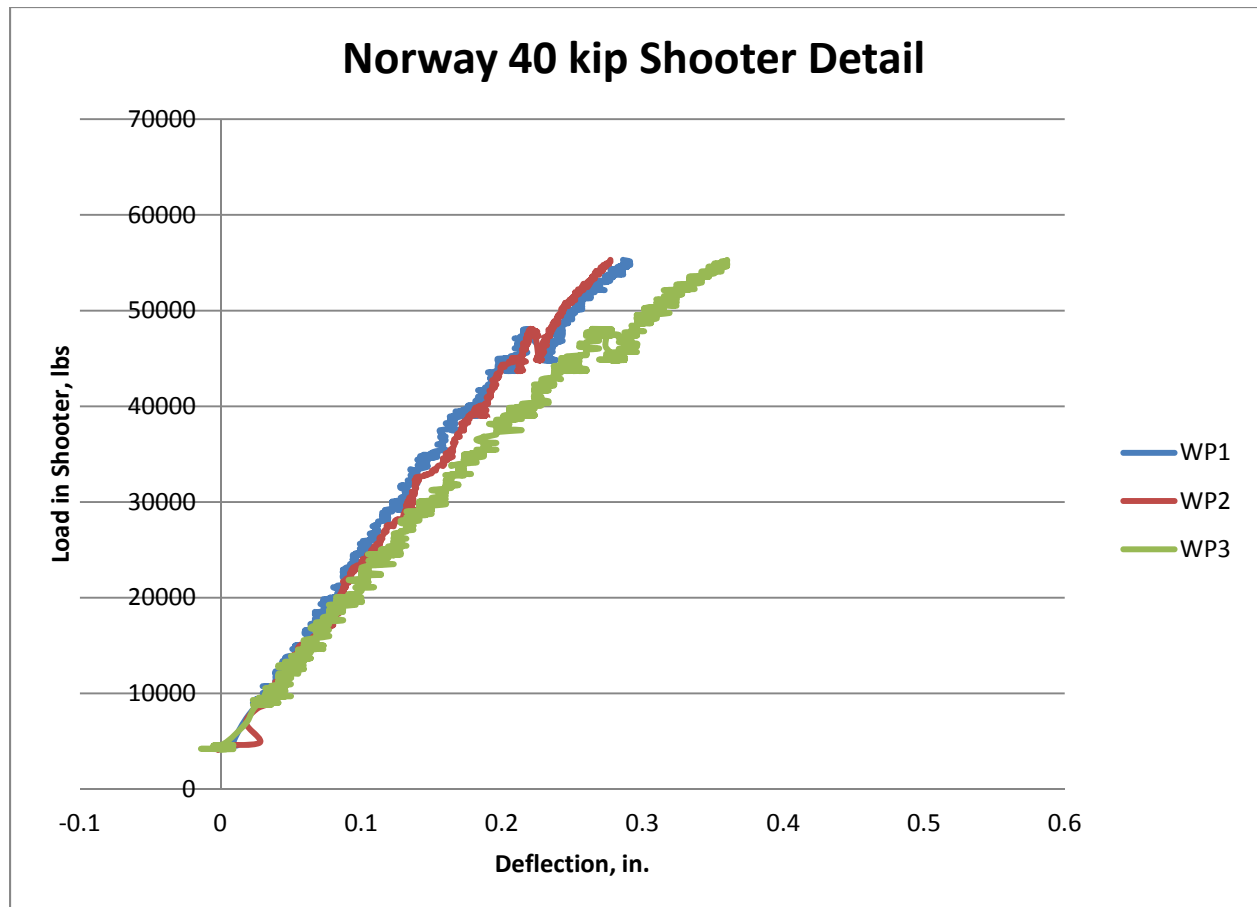
Figure 22: Load vs. Deflection for N40 Test

the three different wire pots are similar and can be considered equivalent. This indicates that the displacement of the beam is small, and there is no separation between the shooter and the concrete.

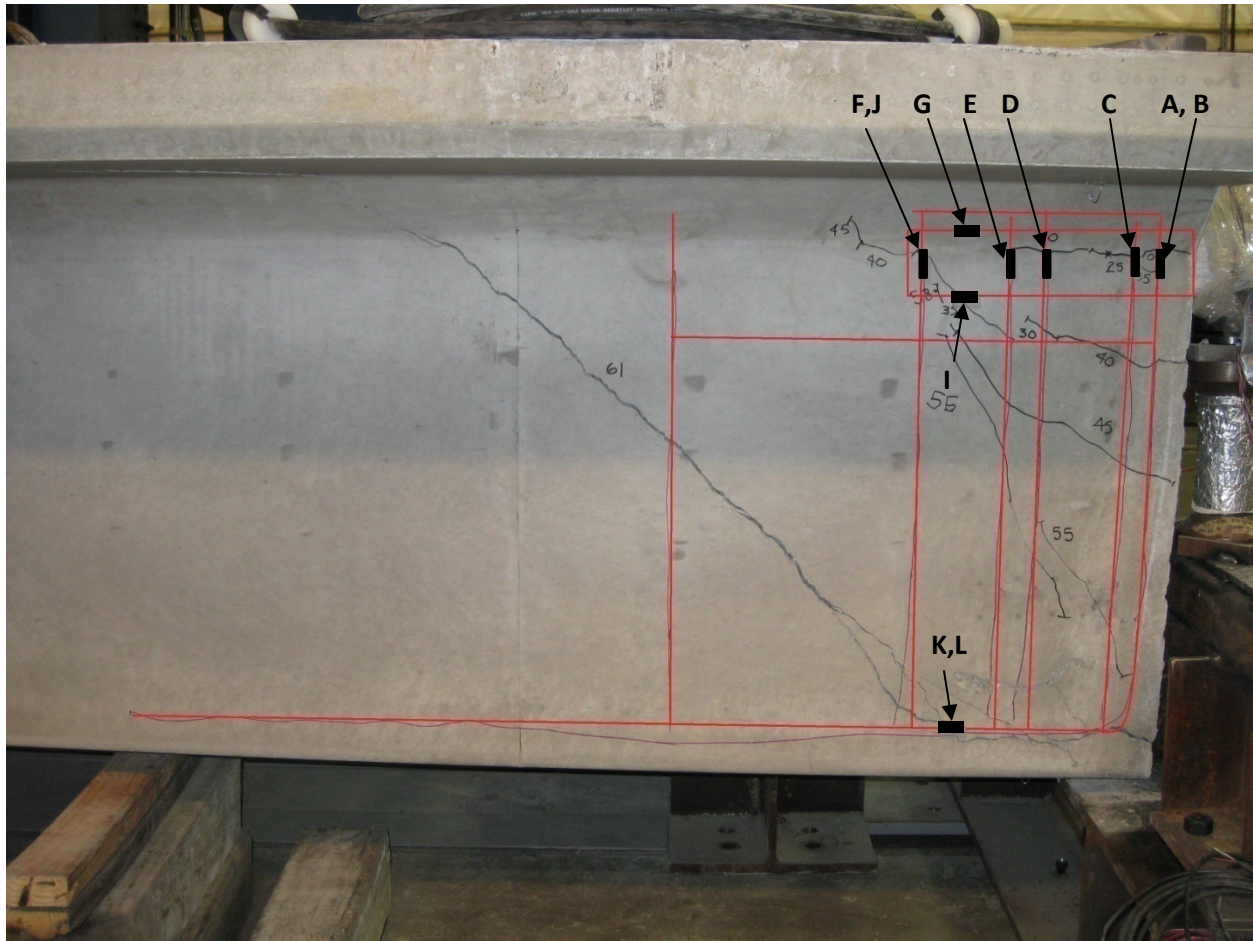
Figure 23: J40 Test

The final test performed was on the Jason 40 kip Shooter. All instrumentation was zeroed the same way as the previous tests, while the shooter was not resting on the beam. Loading proceeded until 10 kips was registered in the load cell under the shooter, followed by additional increments of 5 kips until failure. After each increment of loading, cracks were marked and then monitored to see how much, if any, they opened. This shooter failed at 61.3 kips, exceeding the capacity of all the other shooters. Unlike the previous tests, cracks did not appear until higher loads and the warning crack at 48 kips did not occur. Failure for this test was much more sudden than the other tests.

The gages that measured strain for this test are labeled with letters A thru L in Figure 23. Figure 24 shows the relationship between the load in the shooter and the strain in each gage on the rebar and the relationship between the load in the shooter and the strain on the shooter itself. Once again the graphs indicate that gages closer to the double-tee end experienced higher strains during testing and the bars farther from the face of the double-tee experience some tension at lower loads. The lower Victor bars, gages K and L, are not engaged until around 55 kips. However, the cracks formed at 55 kips were not sufficient to be a warning sign of failure. The bar sizes and layout are presented in the shop drawings provided by Unistress located in Appendix A.

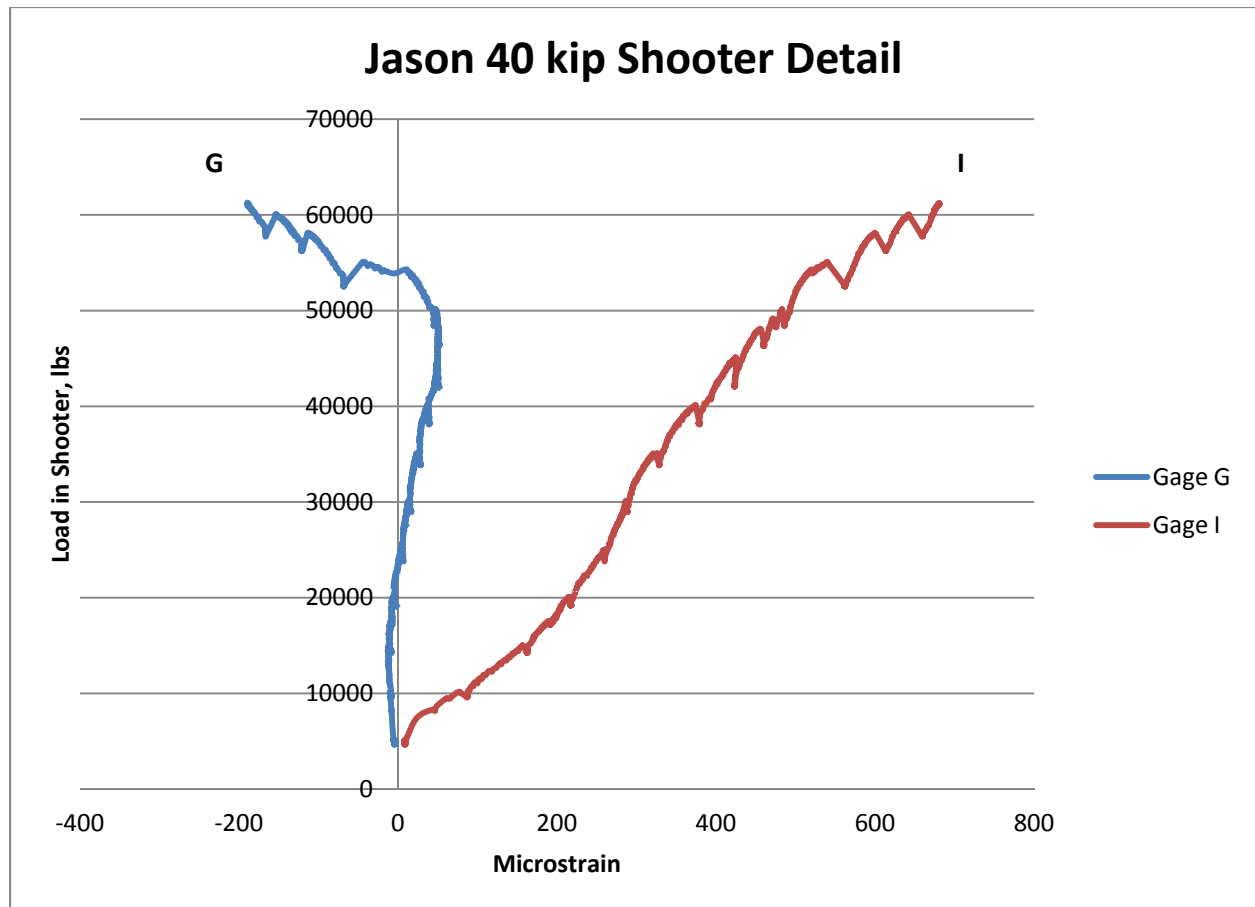
Figure 25: Load vs. Strain for gages on the Shooter in J40 Test

Figure 25 presents the strain measured by the gages adhered to the top and bottom of the outer tube of the shooter (gage I on bottom, gage G on top). As expected, the bottom of the tube experiences tension. Similar to what was seen in the Norway 40k tests, the strain in the top of the tube begins in compression, becomes tensile, and then returns to compression. Further analysis will be performed on the shooter itself. The strains at this location in the shooter also remain quite small (less than $700\mu\epsilon$).

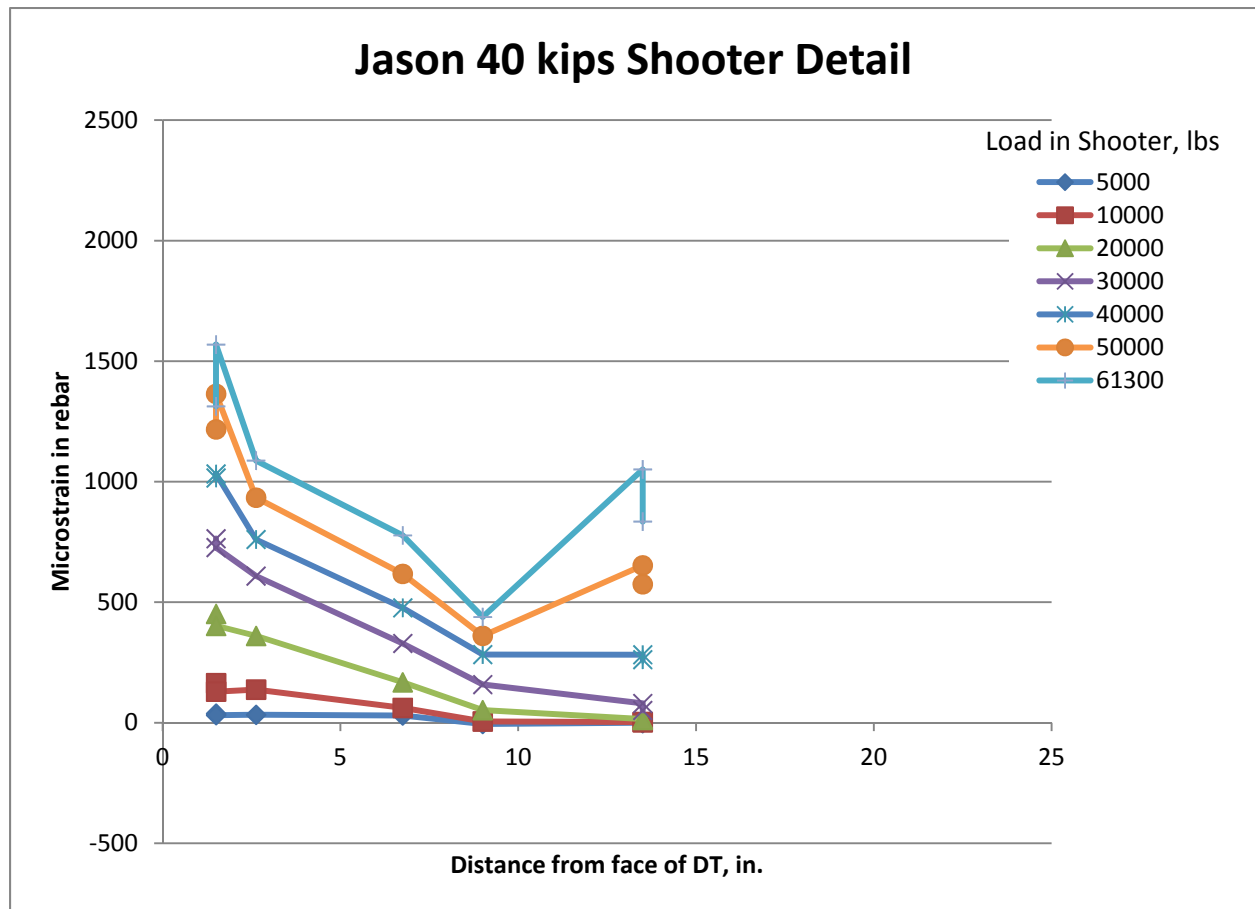
Figure 26: Microstrain in rebar vs. Distance from face of the double-tee for J40 Test

The next three graphs plot the strain in the rebar versus the distance from the face of the double-tee, the force in the front bars versus the load in the shooter, and the displacements of the three wire pots versus the load in the shooter. Figure 26 indicates that as the distance from the face of the double-tee increases, the strain in each gage decreases in a slightly parabolic manner at each load step represented. Figure 27 indicates that the force resisted by the shooter is linearly related to the force in the first four bars of the cage. In previous calculations using a strut-and-tie model to determine the amount of reinforcing, it was estimated that the force in this region would be similar to the results obtained. Thus the reinforcing provided is sufficient to carry the load present in this region. In Figure 28 the displacements plotted for the three different wire pots are similar and can be considered equivalent.

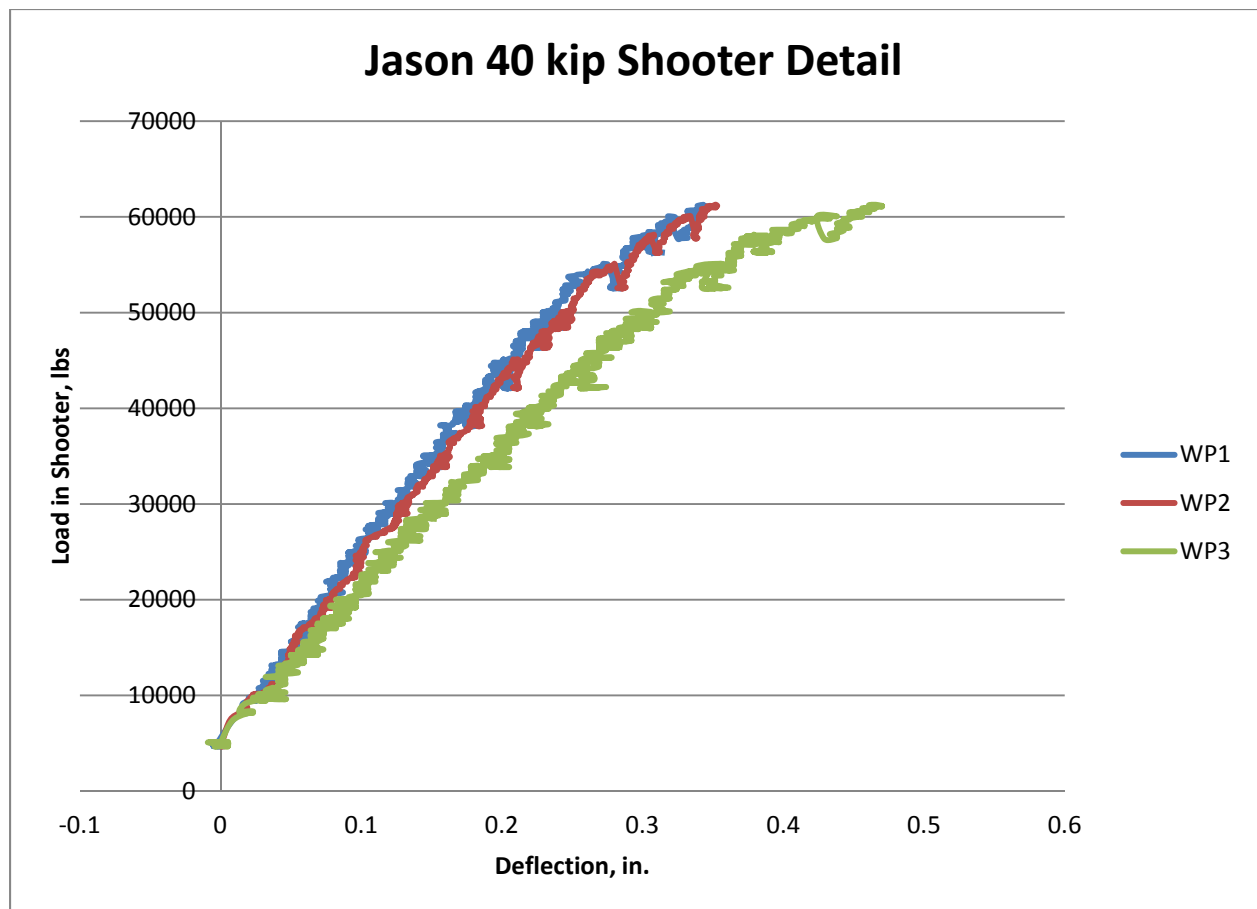
Figure 28: Load vs. Deflection for J40 Test

This indicates that the displacement of the beam is small, and there is no separation between the shooter and the concrete.

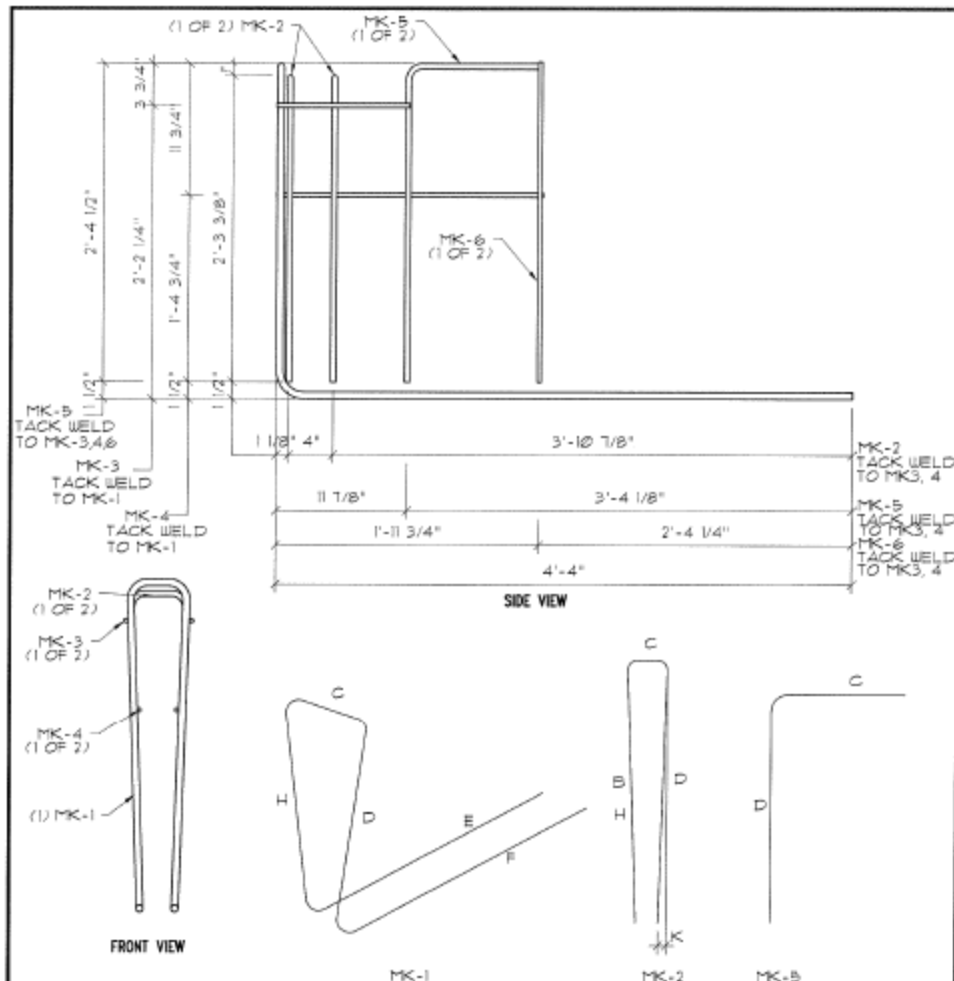
MK	TYPE	SIZE	A	B	C	D	E	F	H	K	SPEC/FINISH
1	UIS	#5 REBAR (5B025)		2'-6"	5 3/4"	2'-6"	4'-4"	4'-4"	2'-6"	1"	A706/BLK
2	HTB	#4 REBAR (4B081)		2'-3 1/4"	5 1/4"	2'-3 1/4"			2'-3 1/4"	3/4"	A706/BLK
3		#3 REBAR x 1'-0"									A706/BLK
4		#3 REBAR x 2'-0"									A706/BLK
5	IT	#4 REBAR (4B083)			1'-0"	2'-4 1/2"					A706/BLK
6		#3 REBAR x 2'-5"									A706/BLK
OWN. BY: HR			CHK. BY:		DATE: 11/13/08		SHOOTER REINFORCEMENT FOR NORWAY 40K				CHARGE CODE: 3332
NO.	REVISION		DATE		BY:		PROJECT: JVI SHOOTER DT				JOB NO: 40814
4							unistress P.O. BOX 1145, PITTSFIELD, MA 01202				814P 123
5											
6											
7

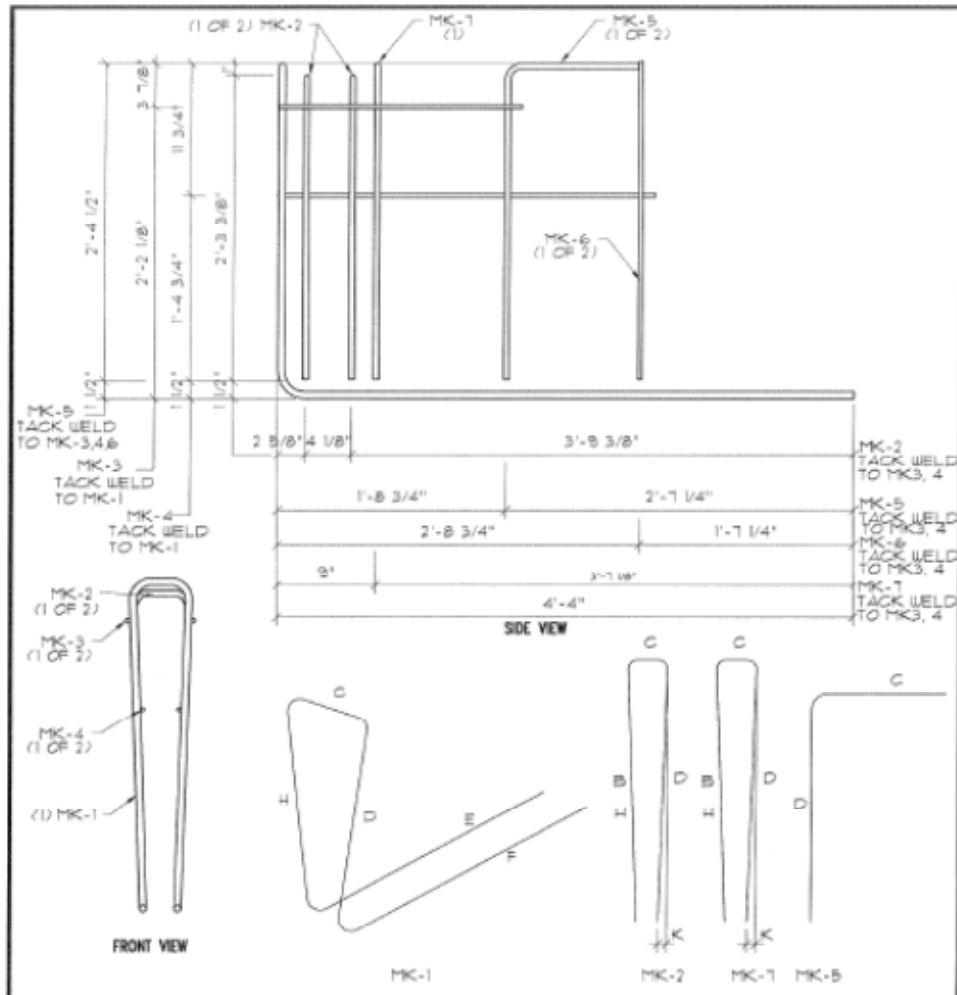
WK	TYPE	SIZE	A	B	C	D	E	F	H	K	SPEC/FINISH		
1	U/S	#5 REBAR (5B0025)		2'-6"	5 3/4"	2'-6"	4'-4"	4'-4"	2'-6"	1"	A706/BLK		
2	H/S	#4 REBAR (4B0017)		2'-3 1/4"	5 1/4"	2'-3 1/4"			2'-3 1/4"	3/4"	A706/BLK		
3		#3 REBAR x 1'-10"									A706/BLK		
4		#3 REBAR x 2'-10"									A706/BLK		
5	I/I	#4 REBAR (4B0093)			1'-0"	2'-4 1/2"					A706/BLK		
6		#3 REBAR x 2'-5"									A706/BLK		
7	H/S	#4 REBAR (4B0088)		2'-4 1/2"	5 1/4"	2'-4 1/2"			2'-4 1/2"	1"	A706/BLK		
OWN. BY: HR			CHK. BY:		DATE: 11/13/08		SHOOTER REINFORCEMENT FOR NORWAY 50K					CHARGE CODE: 3332	
NO.		REVISION		DATE		BY:		PROJECT: JVI SHOOTER DT					JOB NO: 40814
4								JVI SHOOTER DT					
5								unistress					814P
6								P.O. BOX 1145, PITTSFIELD, MA 01202					125
7

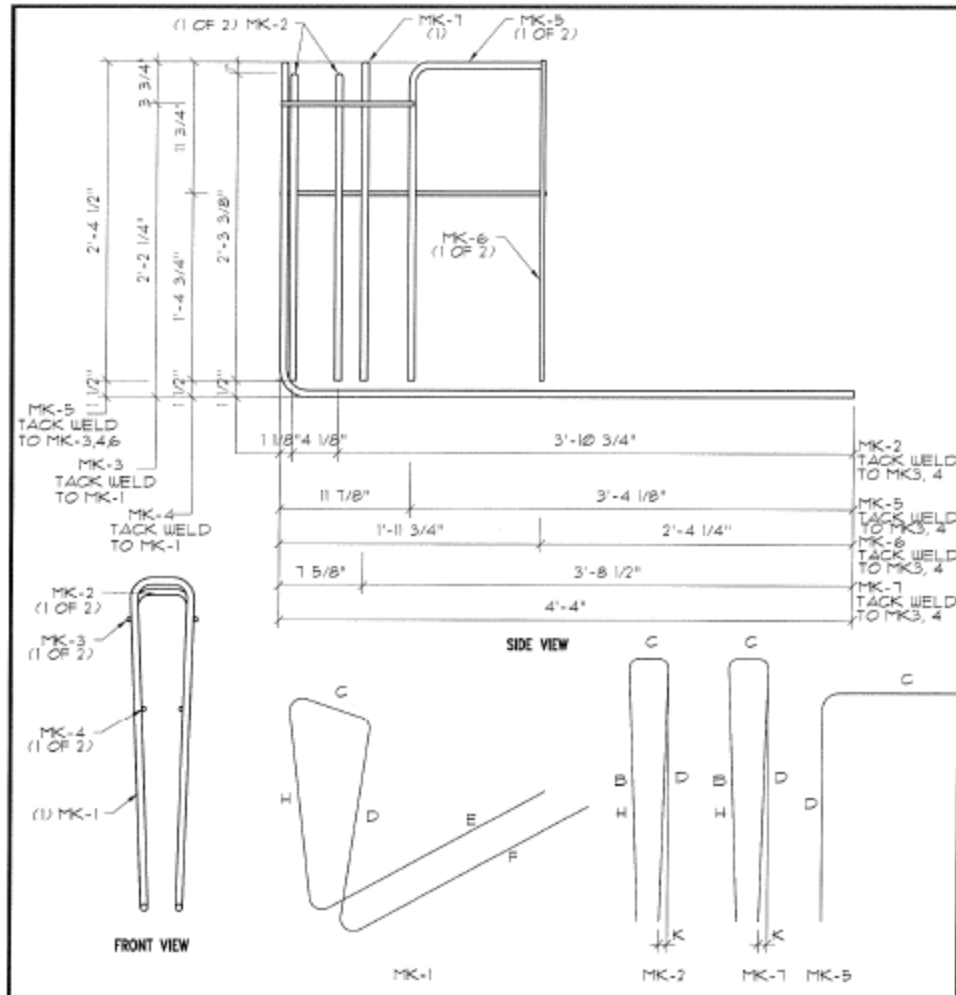
MK	TYPE	SIZE	A	B	C	D	E	F	H	K	SPEC/FINISH
1	UB	#5 REBAR (5B025)		2'-6"	5 3/4"	2'-6"	4'-4"	4'-4"	2'-6"	1"	A706/BLK
2	HTB	#5 REBAR (5B024)		2'-3 1/4"	5 1/2"	2'-3 1/4"			2'-3 1/4"	3/4"	A706/BLK
3		#3 REBAR x 1'-0"									A706/BLK
4		#3 REBAR x 2'-0"									A706/BLK
5	IT	#5 REBAR (5B022)			1'-0"	2'-4 1/2"					A706/BLK
6		#3 REBAR x 2'-5"									A706/BLK
7	HTB	#5 REBAR (5B023)		2'-4 1/2"	5 3/4"	2'-4 1/2"			2'-4 1/2"	1"	A706/BLK
OWN. BY: HR			CHK. BY:		DATE: 11/13/08		SHOOTER REINFORCEMENT FOR JASON 40K				CHARGE CODE: 3332
NO.			REVISION		DATE		BY:		PROJECT: JVI SHOOTER DT		JOB NO: 40814
4									unistress P.O. BOX 1145, PITTSFIELD, MA 01202		814P 124
5											
6											
7
