The JVI VC4 Vector Connector Compiled Test Reports

Testing of the JVI Mid V in 4" Slabs

Additional Testing of the JVI Mid V in 4" Slabs

Testing of the JVI Vector Connector 4 in 4" Slabs

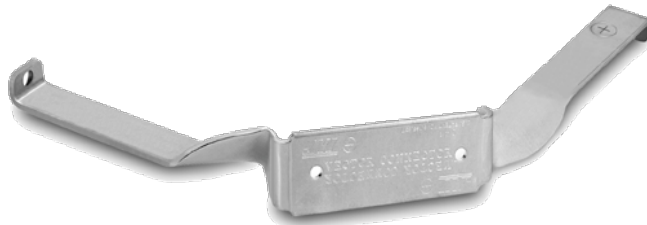
Figure 1: VC2

This report documents the initial testing of a radical vector connector redesign identified as the Mid-V. The Mid-V replaced the VC2 (see Figure 1). The faceplate was reduced from 2" to 1 1/2" in total height and the concrete anchorage was changed to strategic deformation along the length of the vector legs in lieu of a 90° hook (See Figure 2).

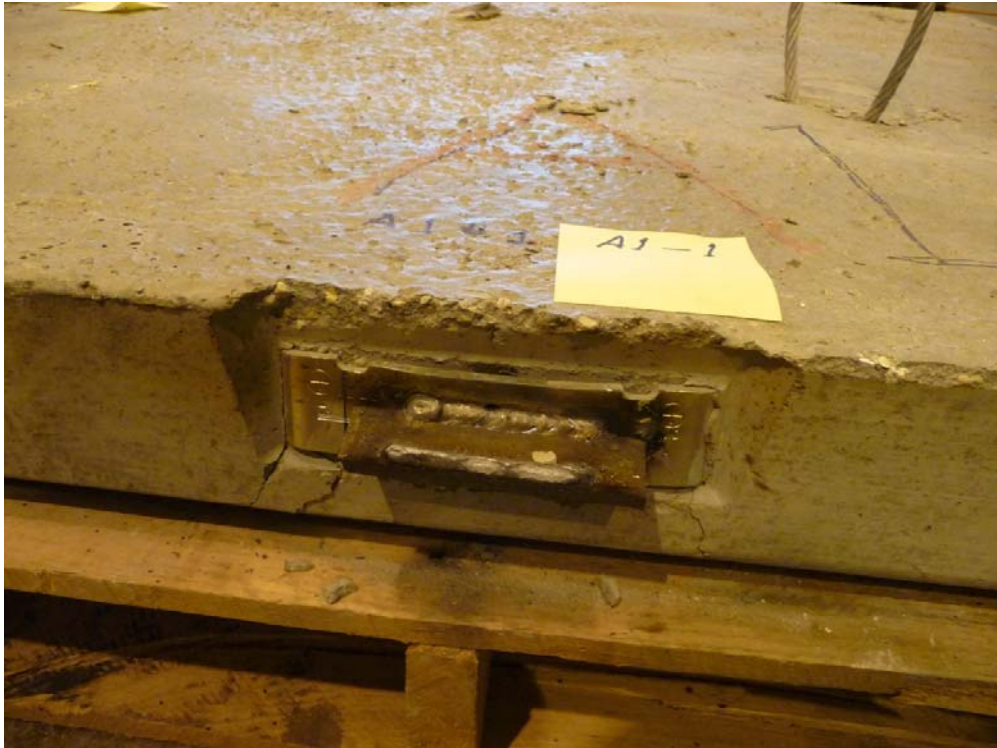
Figure 31 – Test A1-1 Failure Mode – top side view

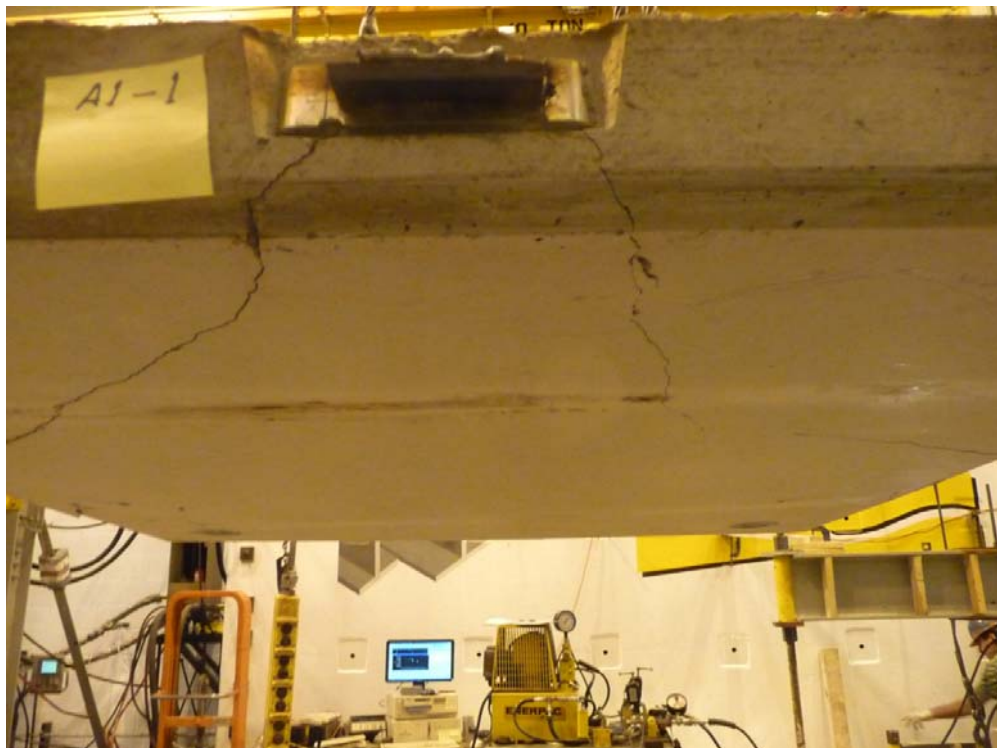
Figure 32 – Test A1-1 Failure Mode – bottom side view

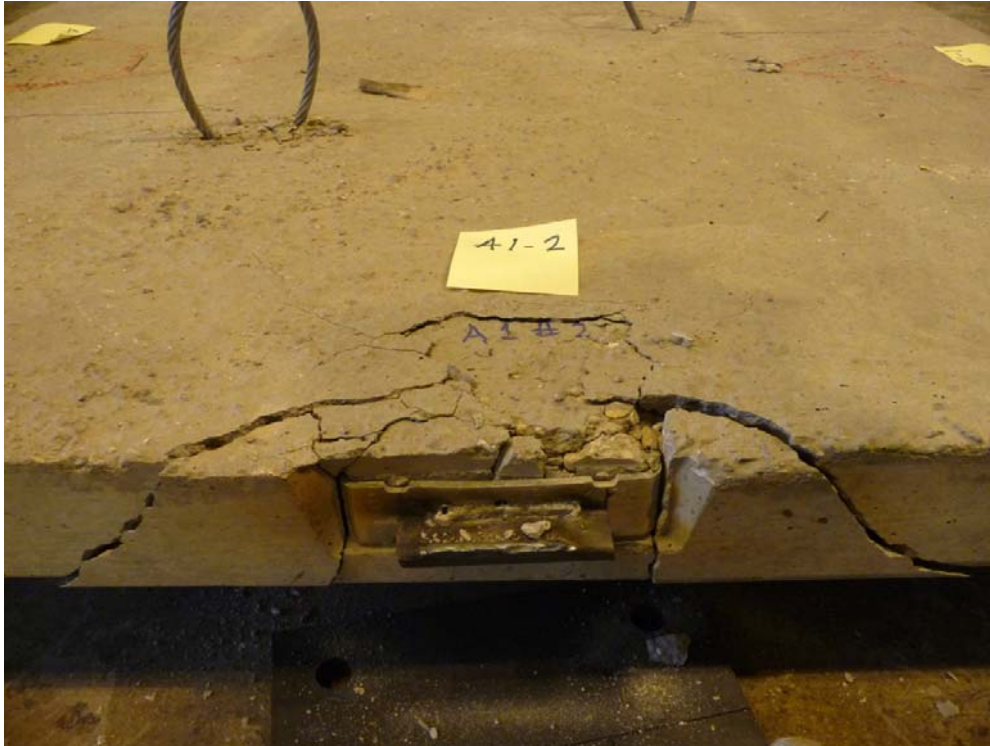
Figure 33 – Test A1-2 Failure Mode – top side view

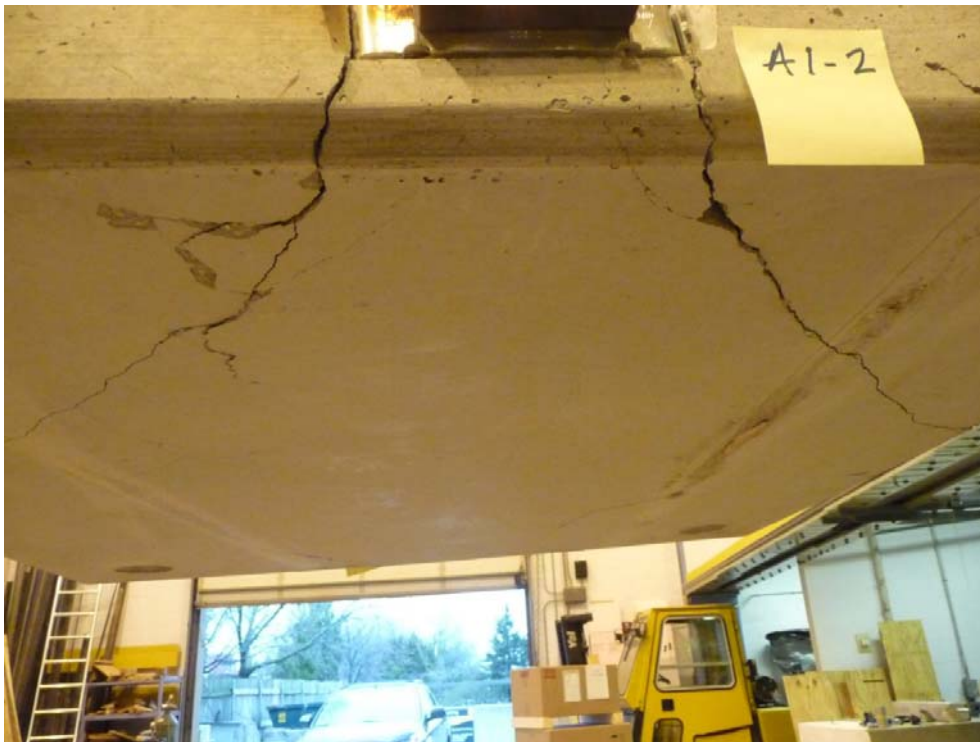
Figure 34 – Test A1-2 Failure Mode – bottom side view

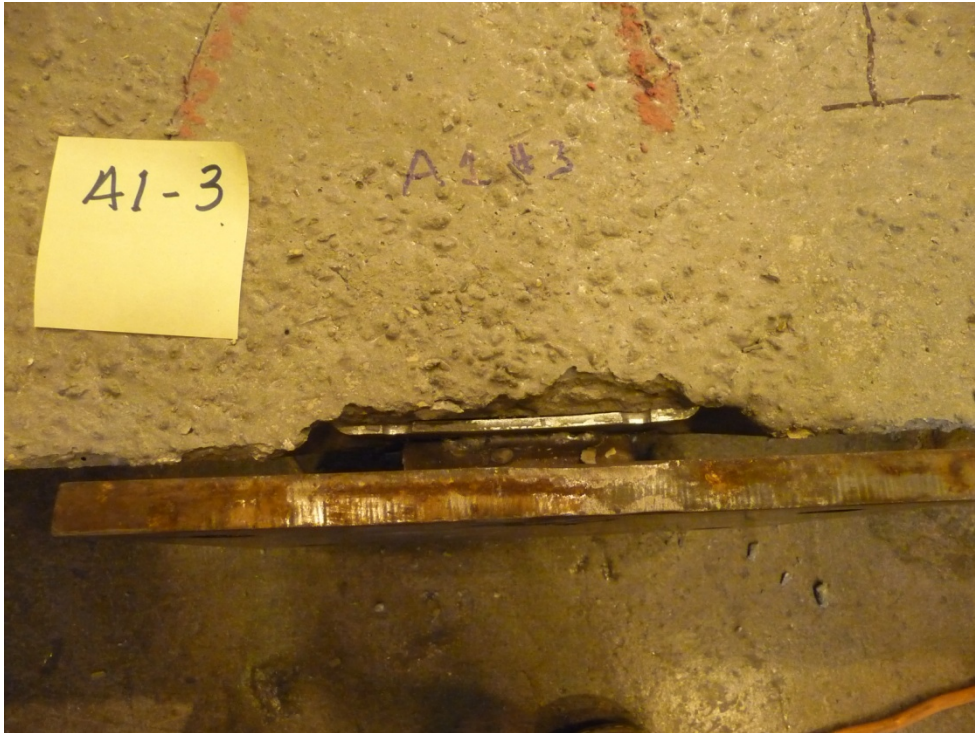
Figure 35 – Test A1-3 Failure Mode – top side view

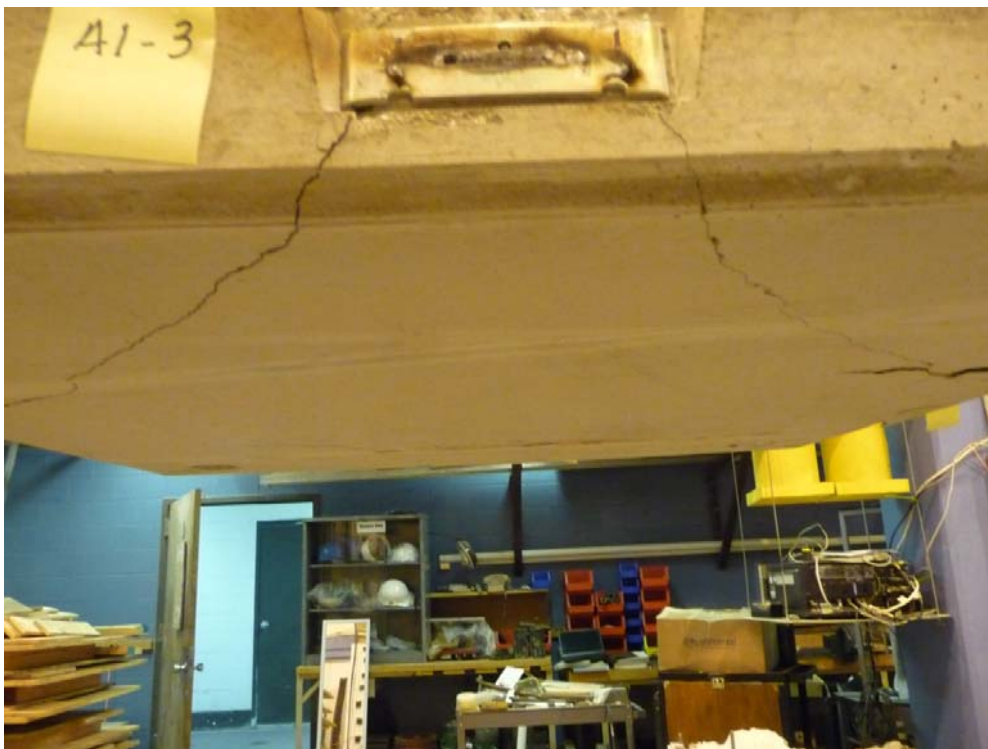
Figure 36 – Test A1-3 Failure Mode – bottom side view

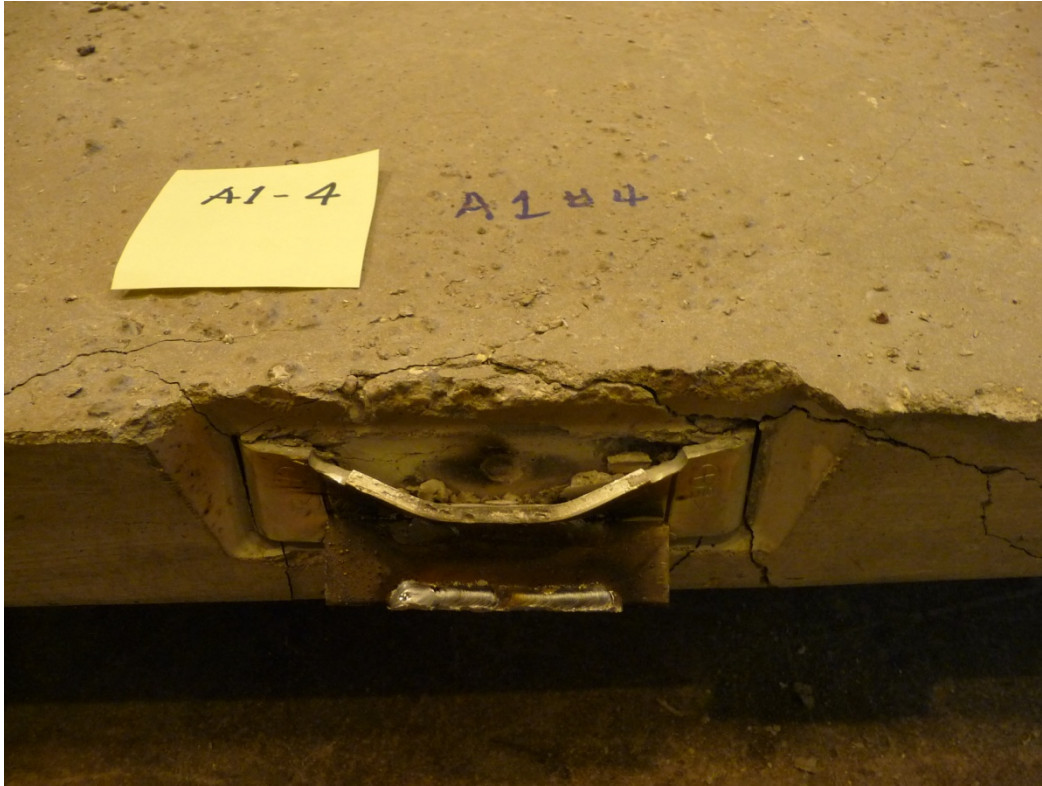
Figure 37 – Test A1-4 Failure Mode – top side view

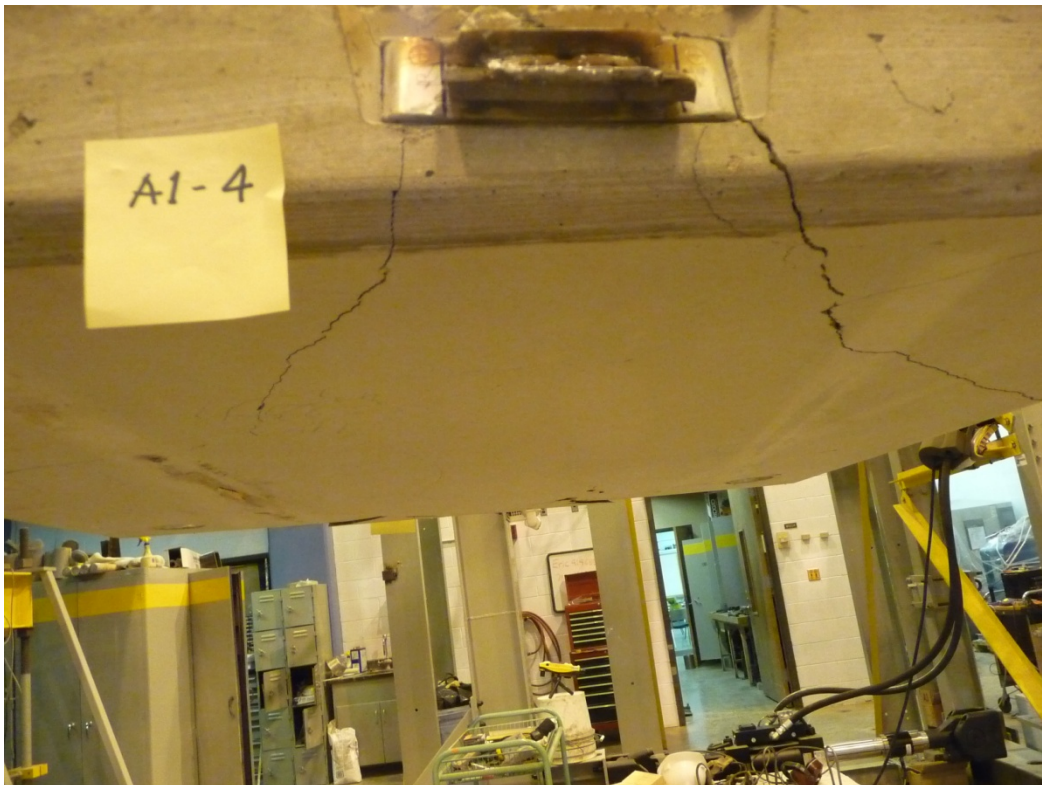
Figure 38 – Test A1-4 Failure Mode – bottom side view

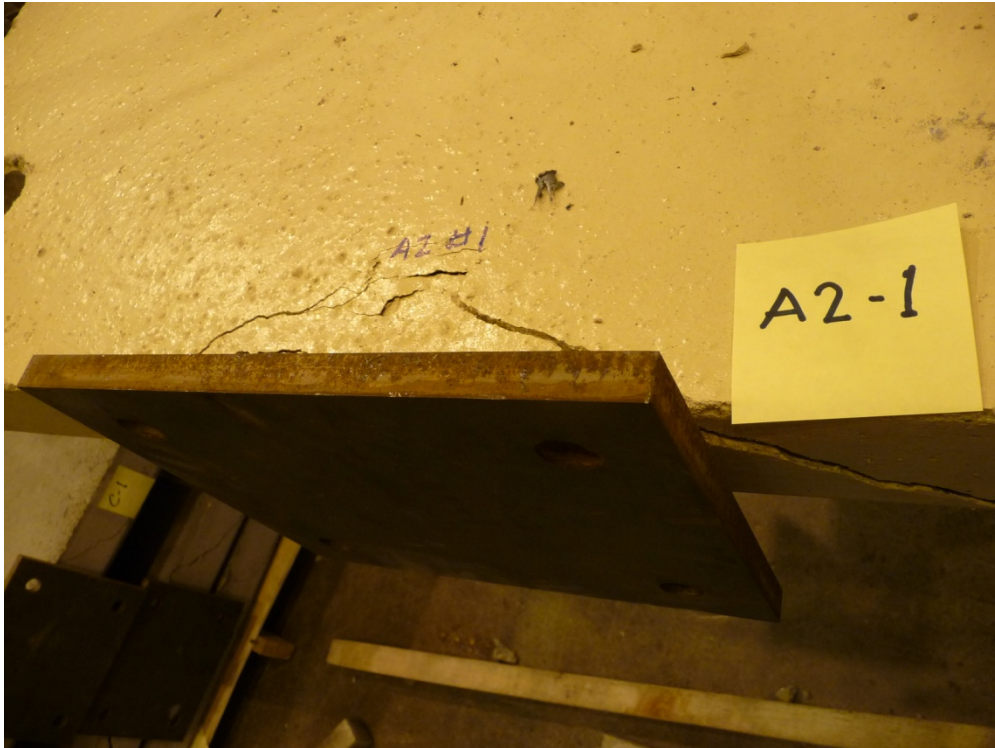
Figure 39 – Test A2-1 Failure Mode – top side view

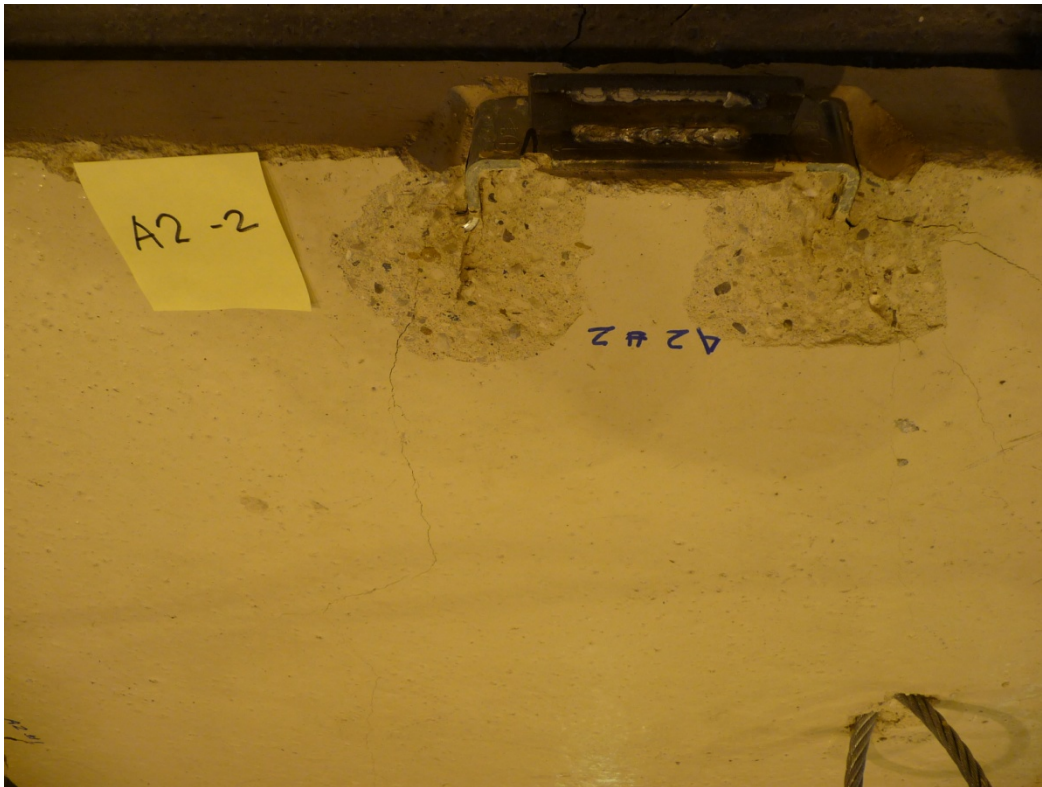
Figure 41 – Test A2-2 Failure Mode – top side view

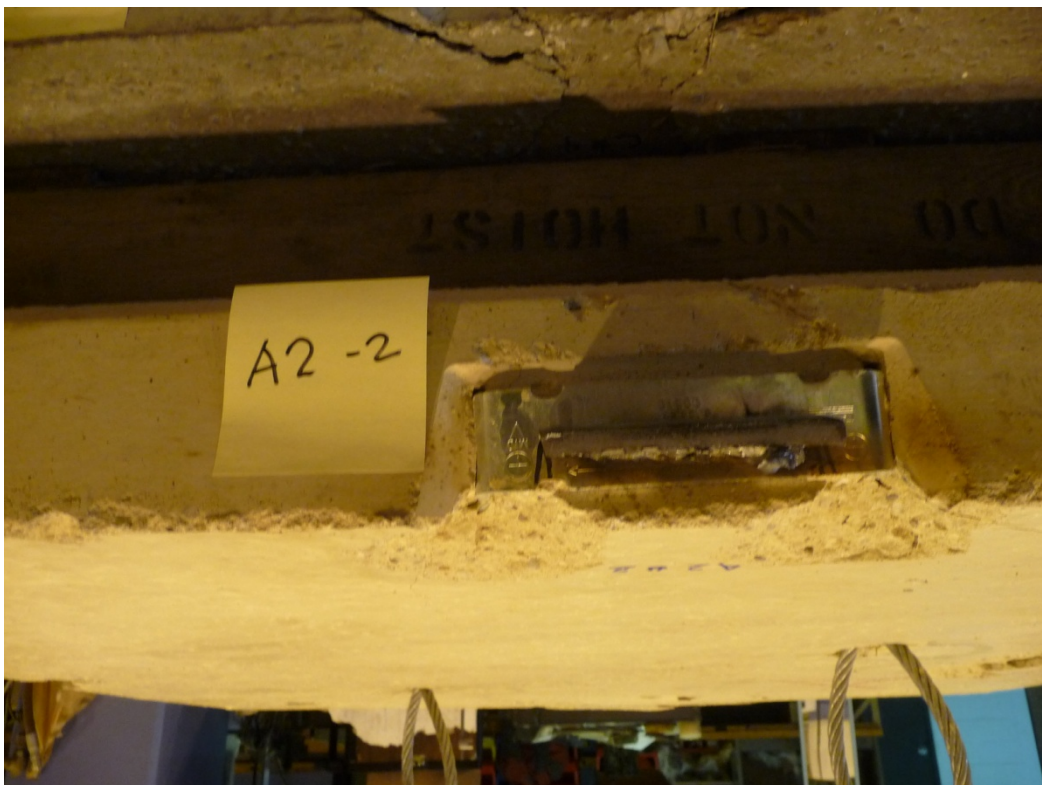
Figure 42 – Test A2-2 Failure Mode – bottom side view

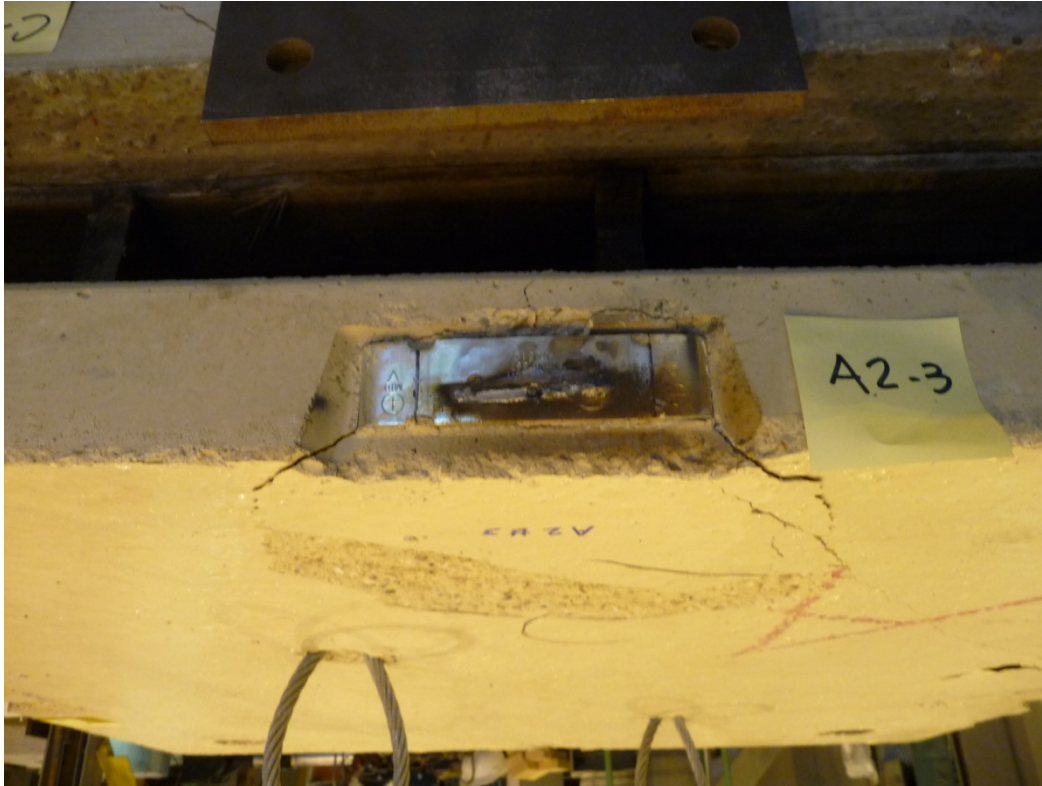
Figure 43 – Test A2-3 Failure Mode – top side view

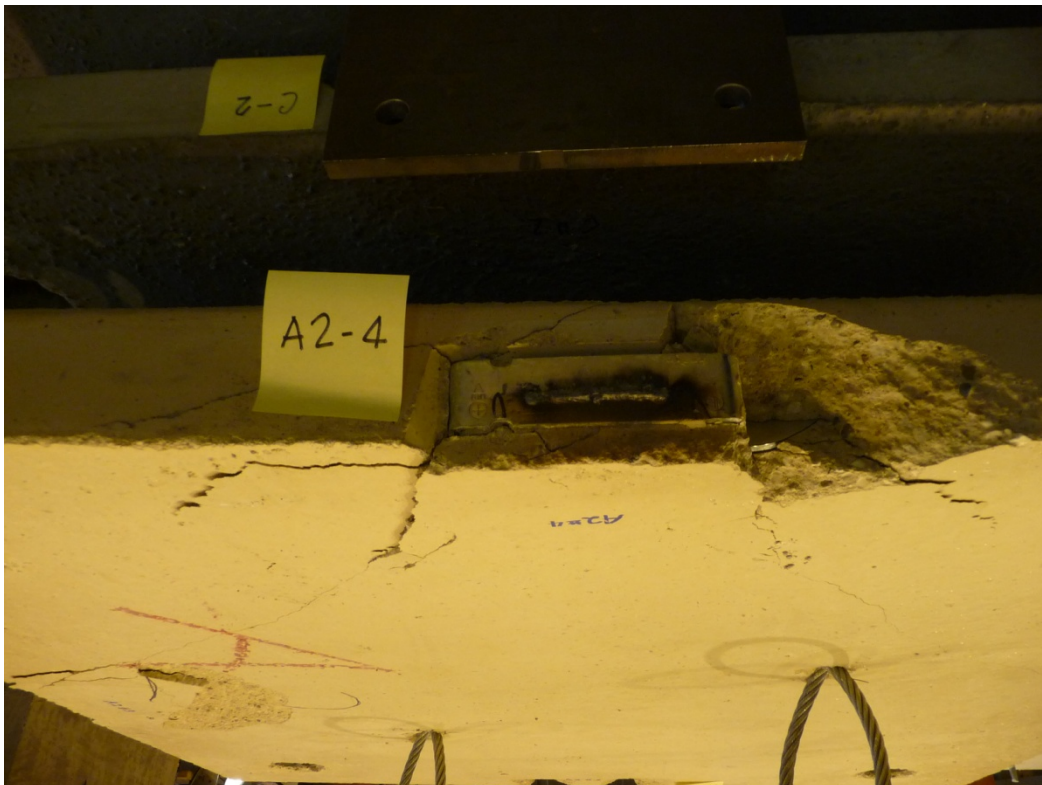
Figure 46 – Test A2-4 Failure Mode – bottom side view

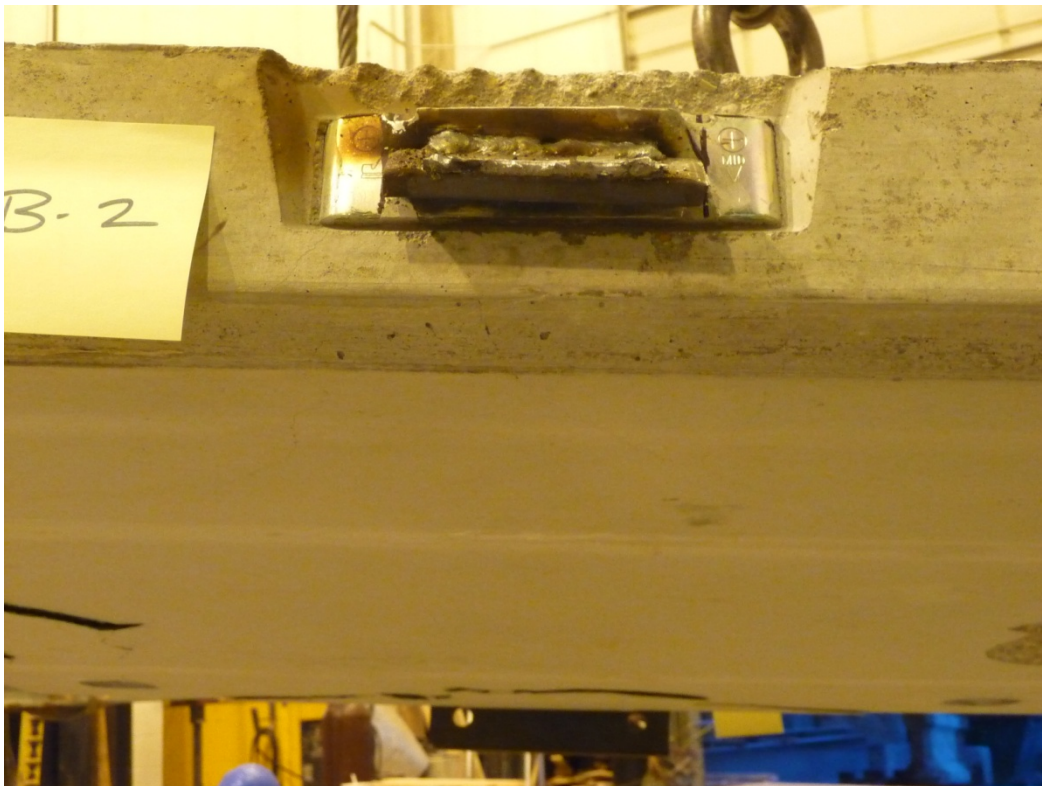
Figure 50 – Test B-2 Failure Mode – bottom side view

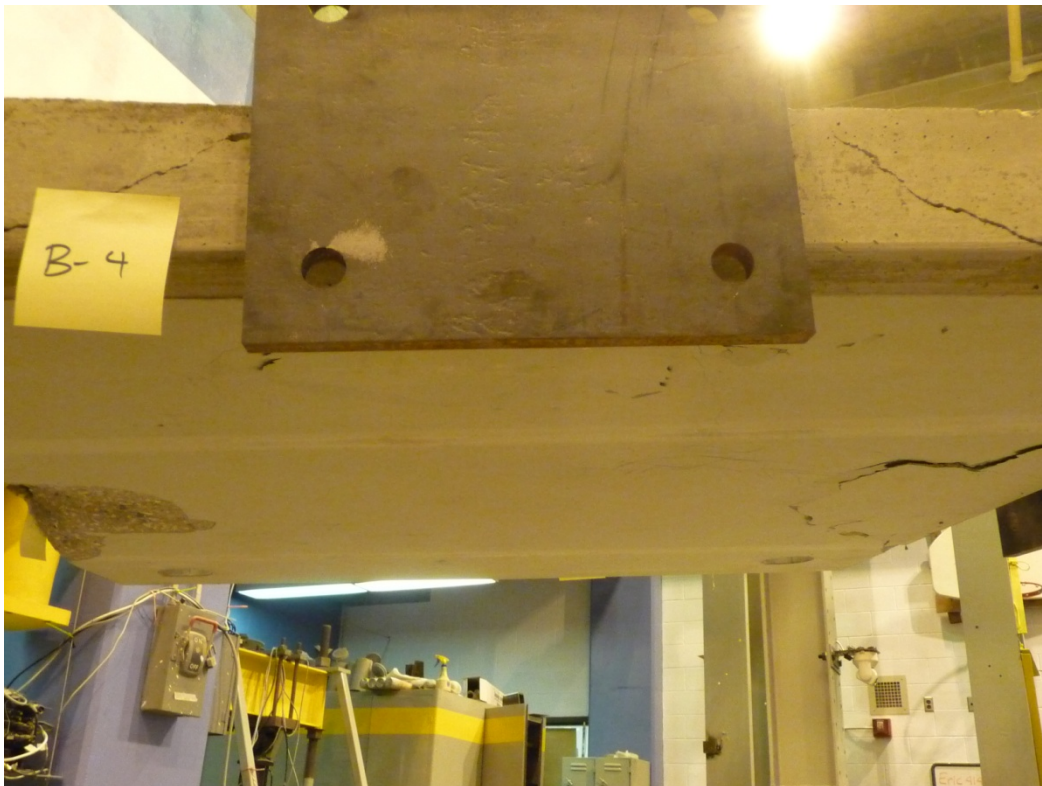
Figure 54 – Test B-4 Failure Mode – bottom side view

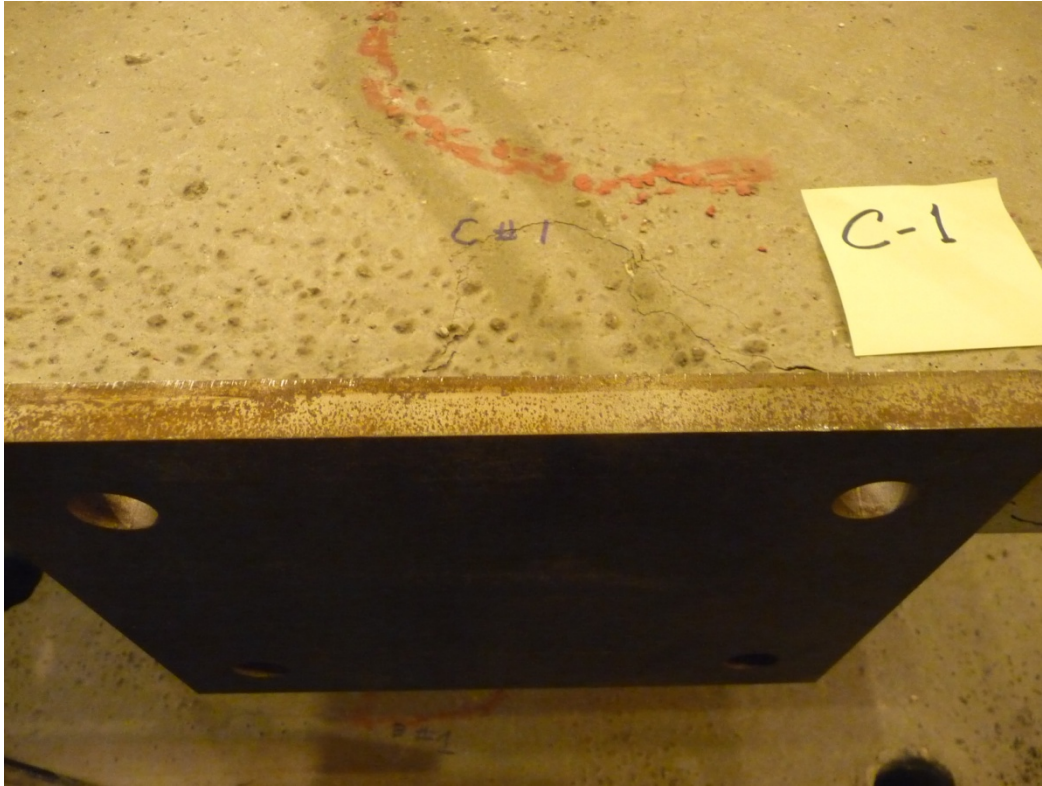
Figure 55 – Test C-1 Failure Mode – top side view

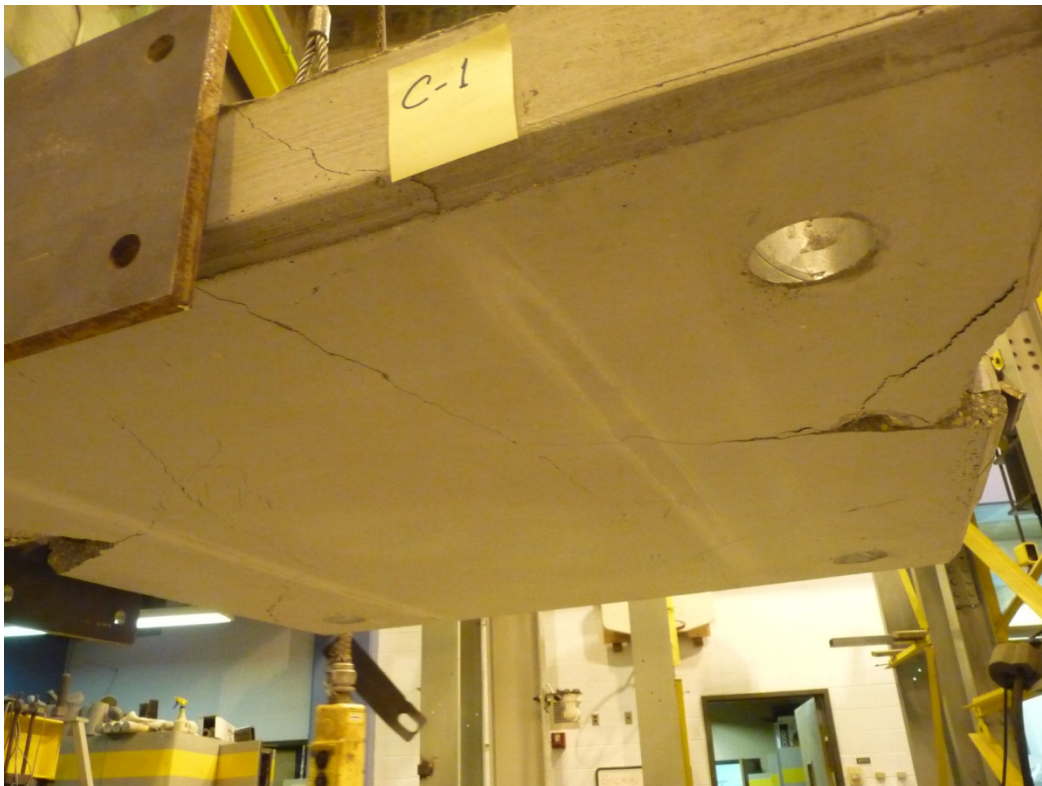
Figure 56 – Test C-1 Failure Mode – bottom side view

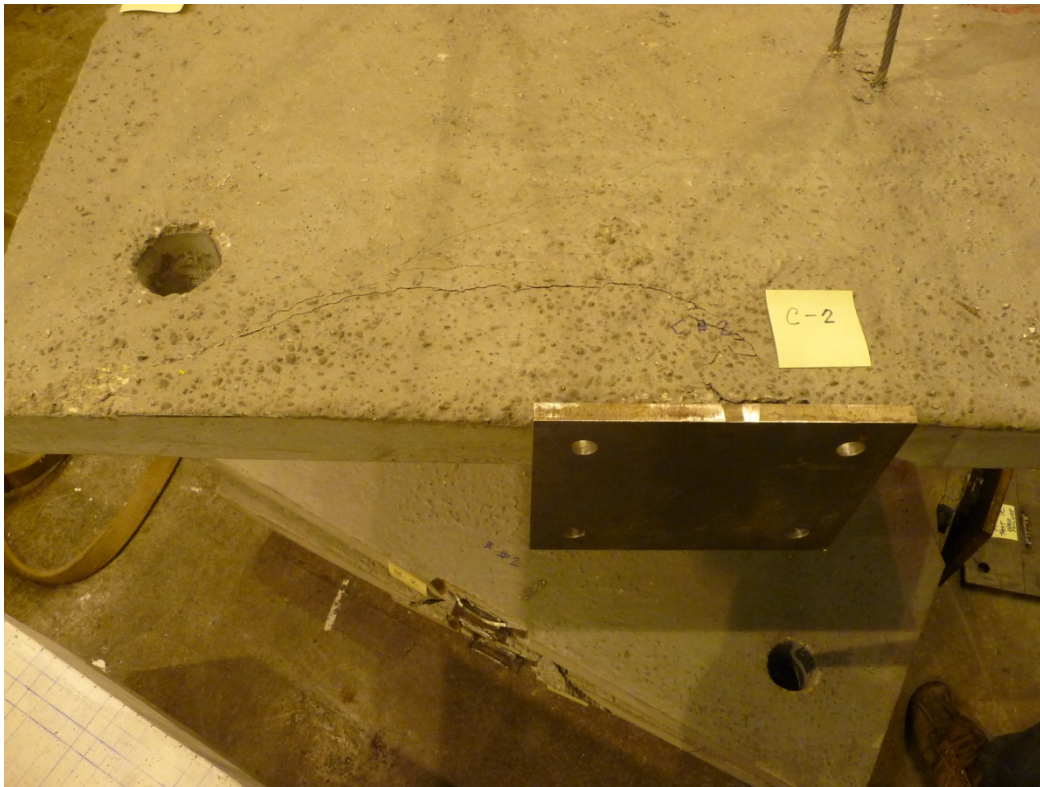
Figure 57 – Test C-2 Failure Mode – top side view

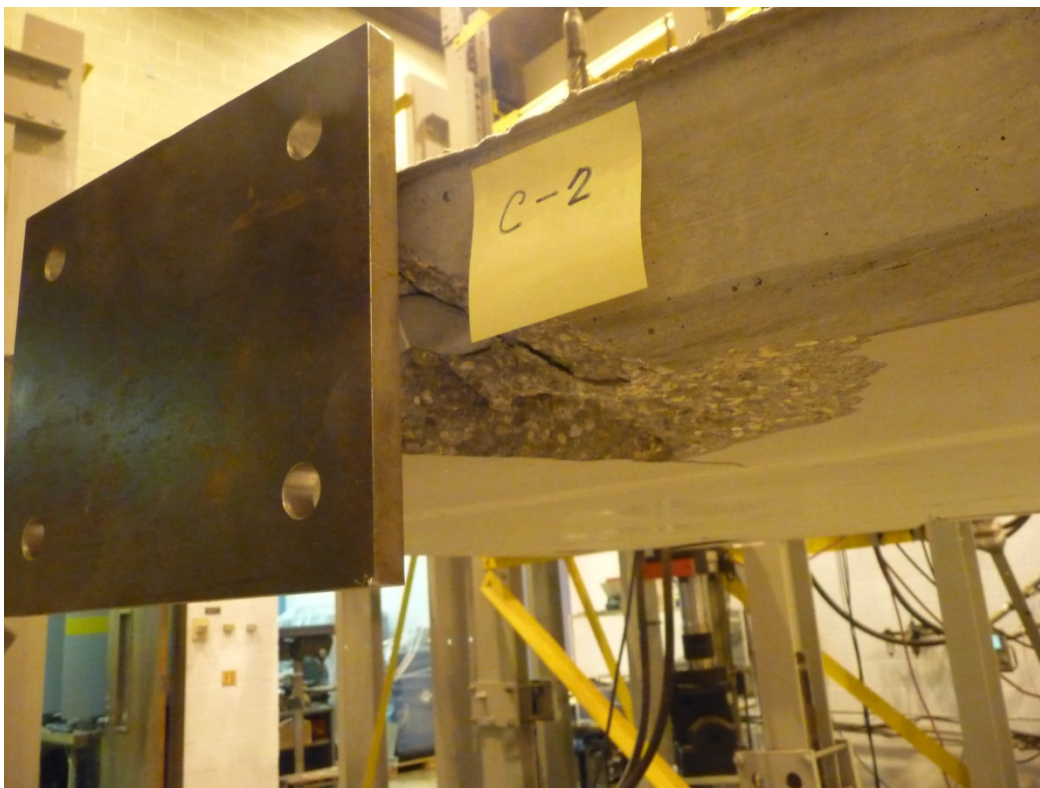
Figure 58 – Test C-2 Failure Mode – bottom side view

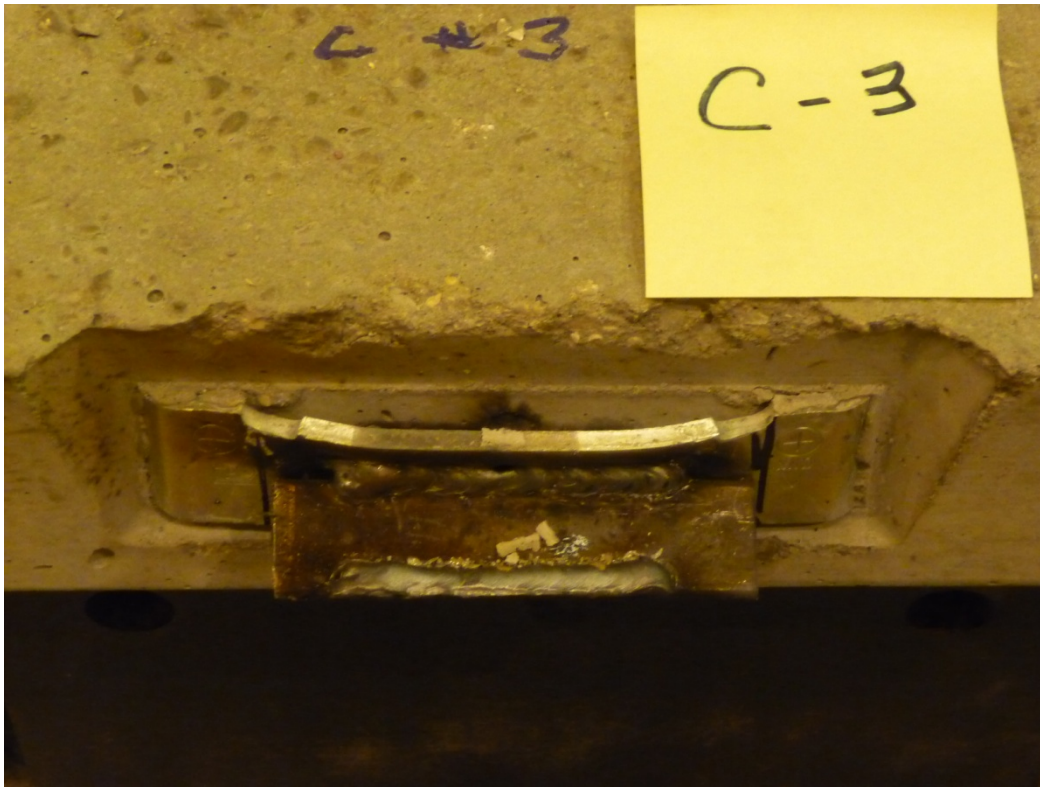
Figure 59 – Test C-3 Failure Mode – top side view

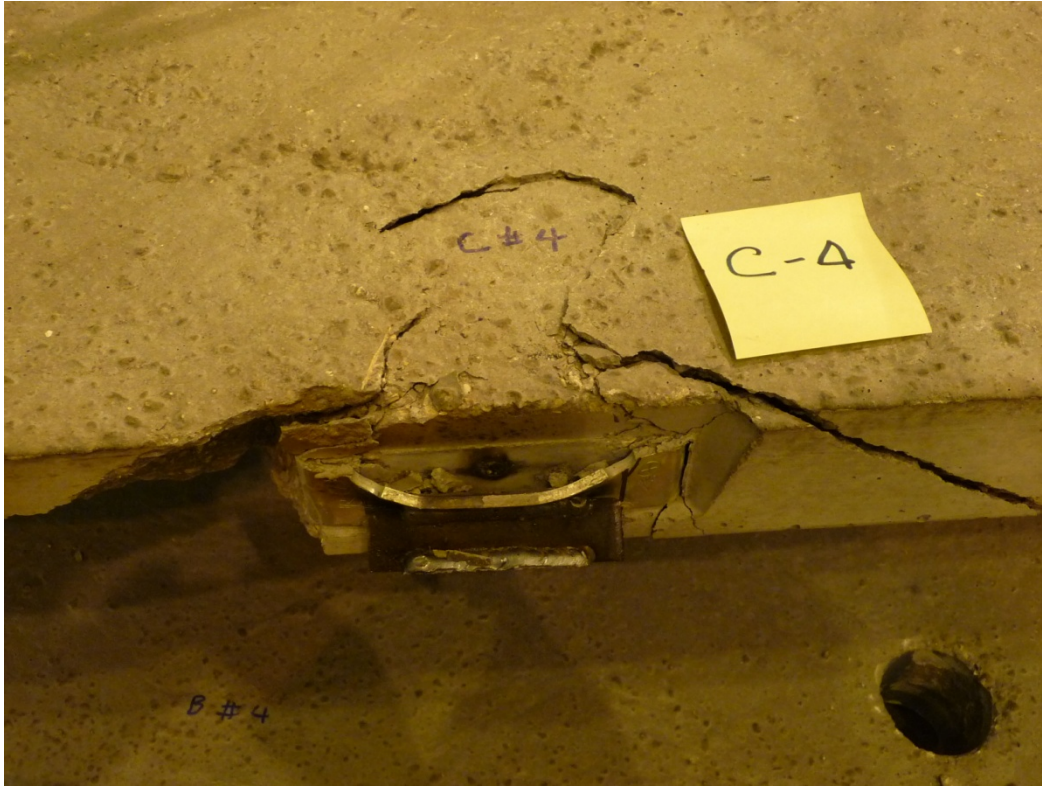
Figure 61 – Test C-4 Failure Mode – top side view

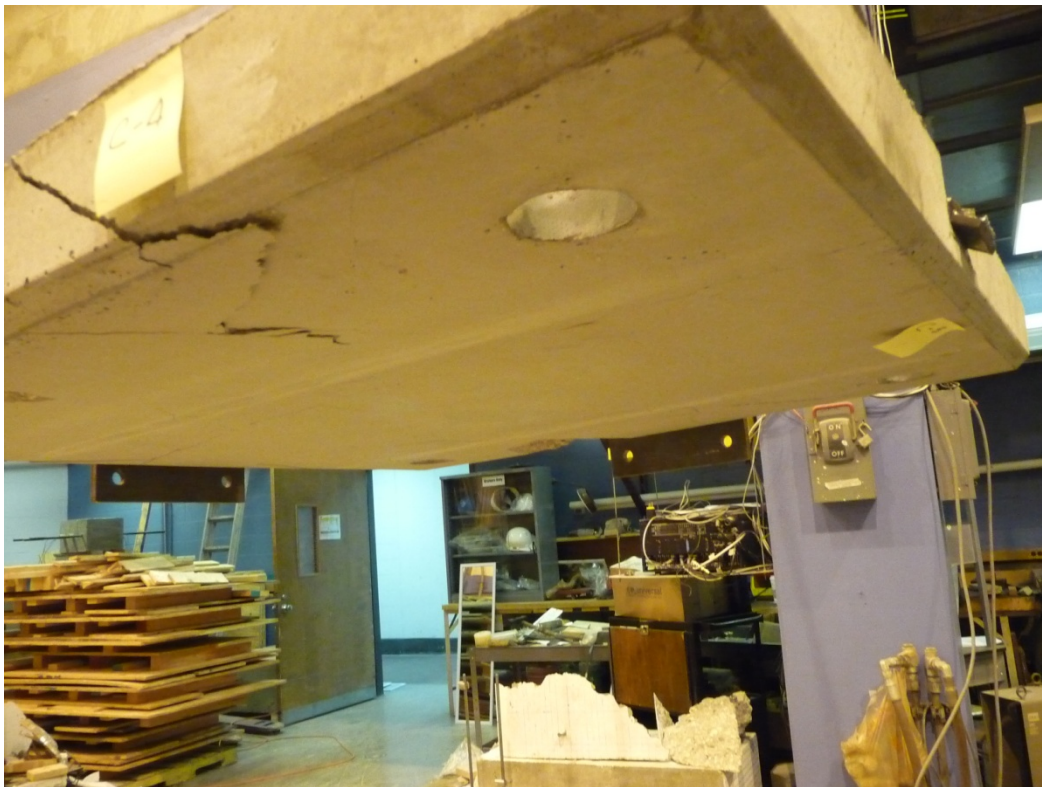
Figure 62 – Test C-4 Failure Mode – bottom side view

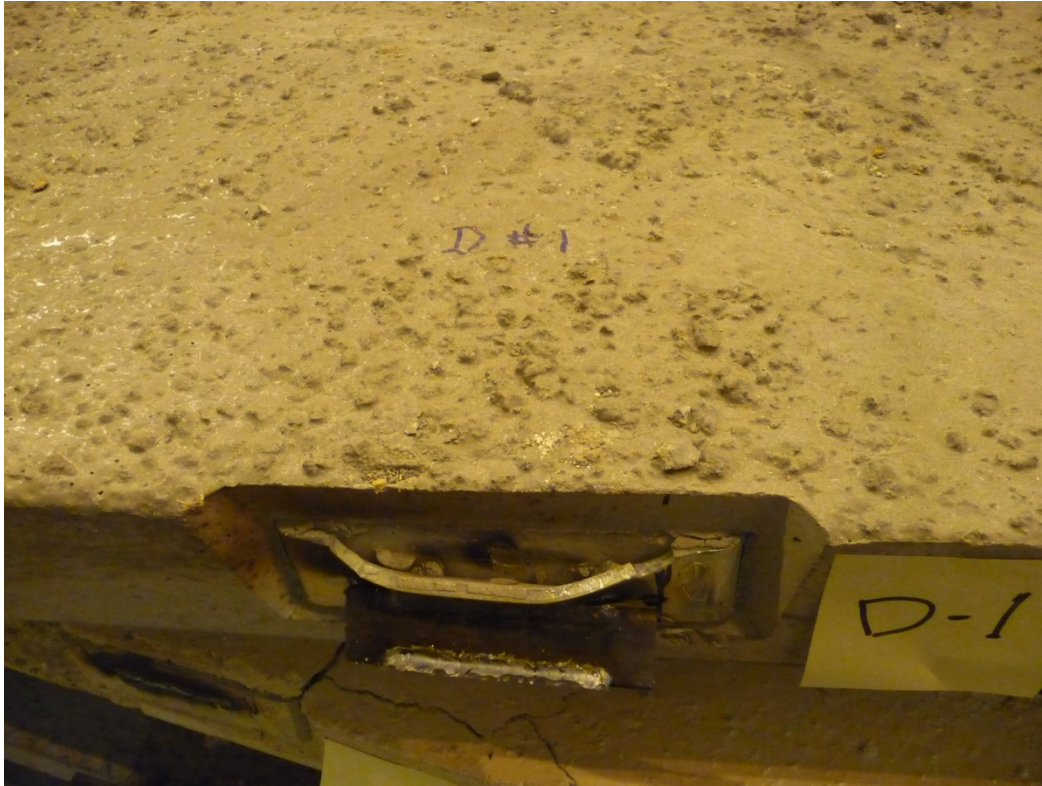
Figure 63 – Test D-1 Failure Mode – top side view

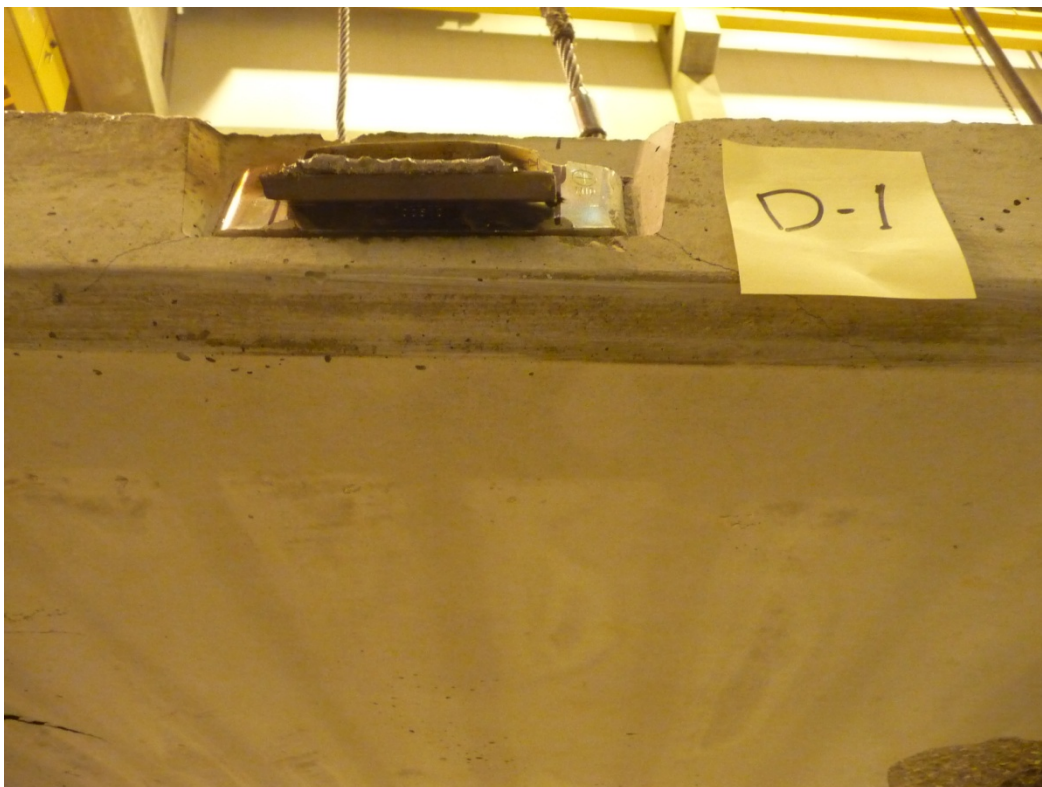
Figure 64 – Test D-1 Failure Mode – bottom side view

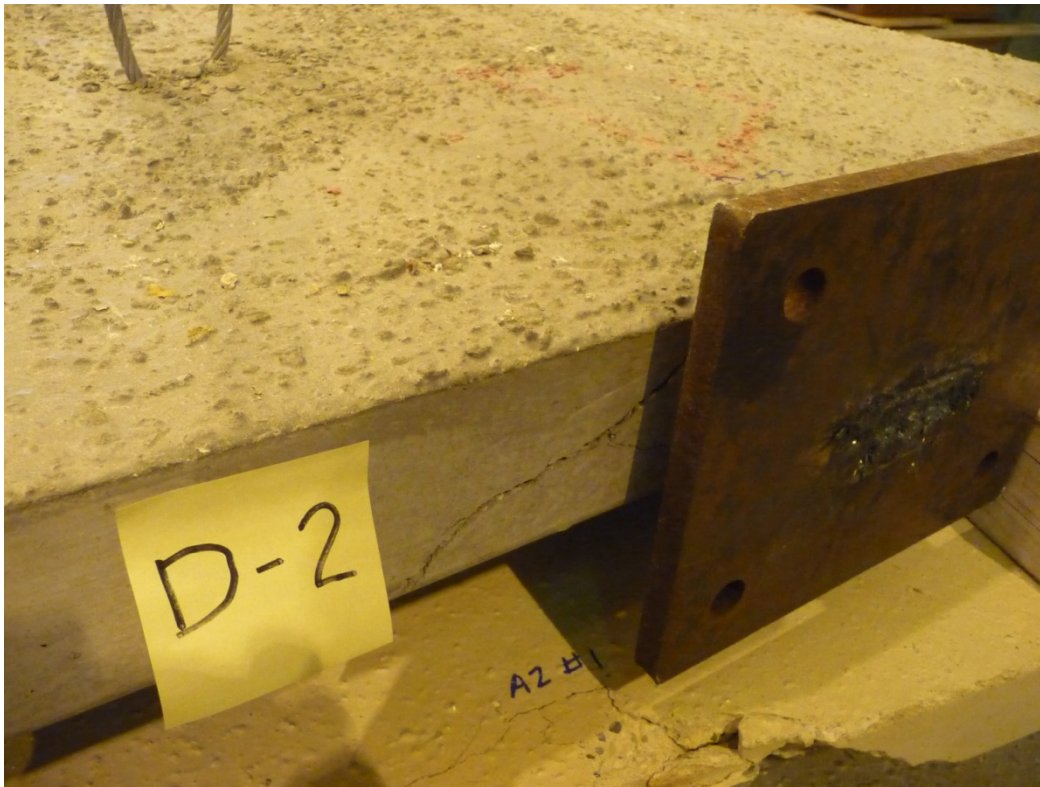
Figure 65 – Test D-2 Failure Mode – top side view

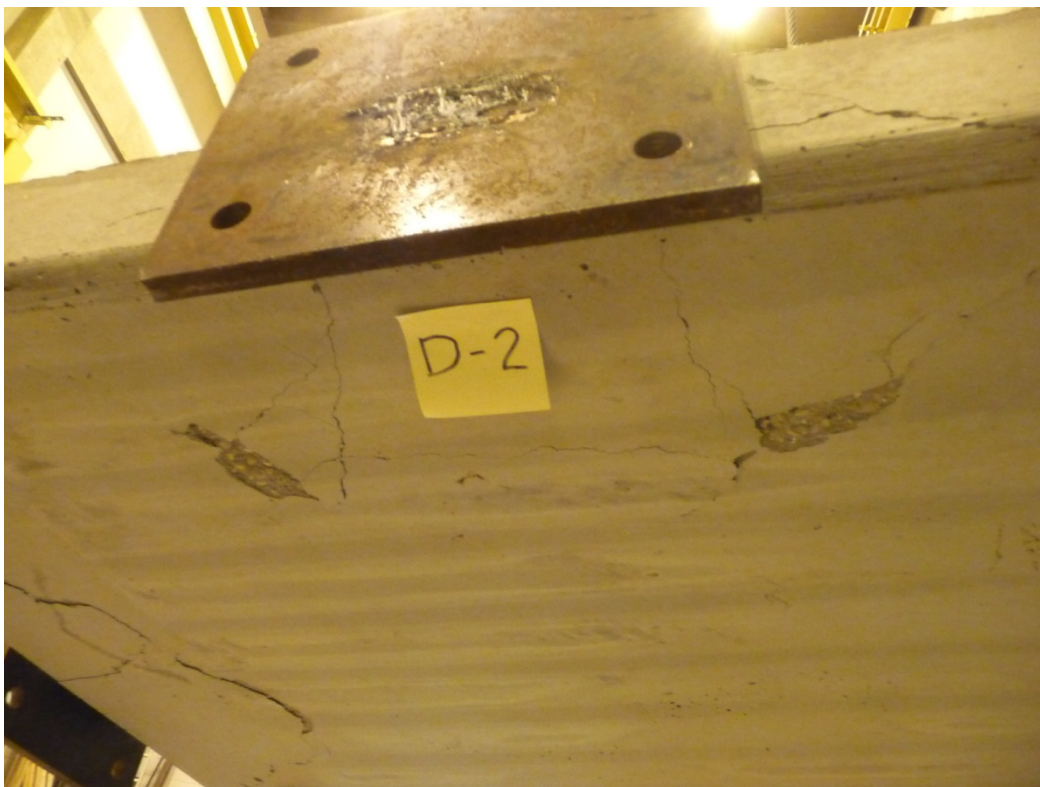
Figure 66 – Test D-2 Failure Mode – bottom side view

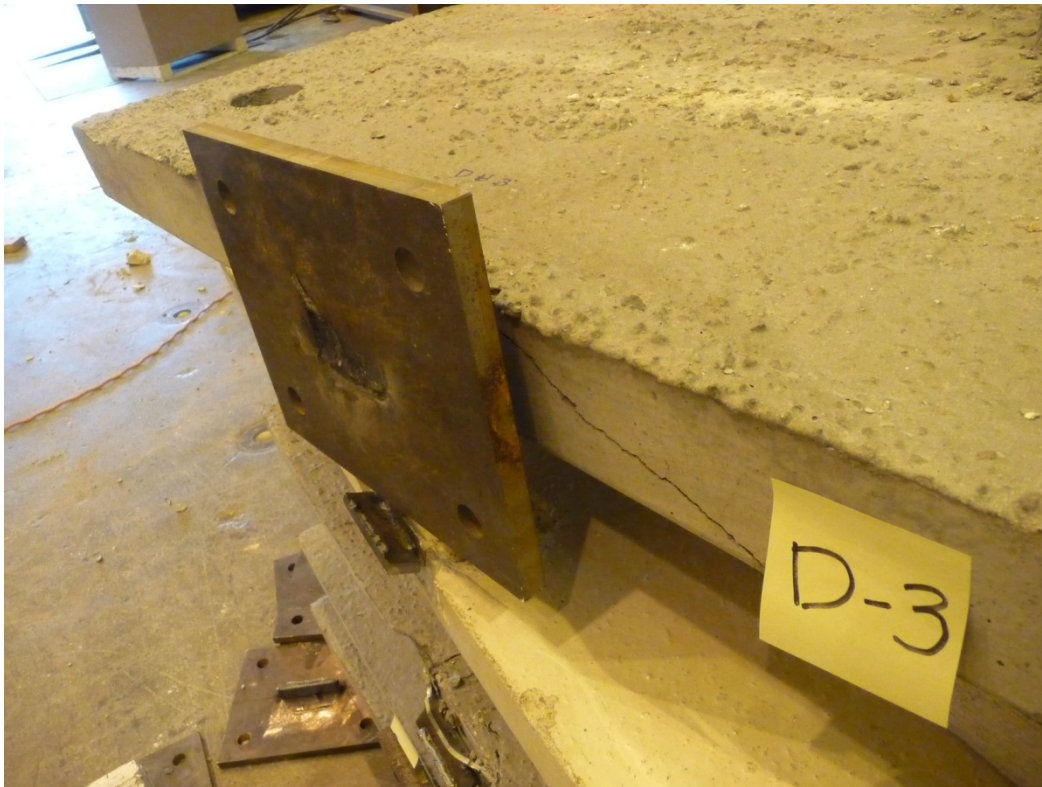
Figure 67 – Test D-3 Failure Mode – top side view

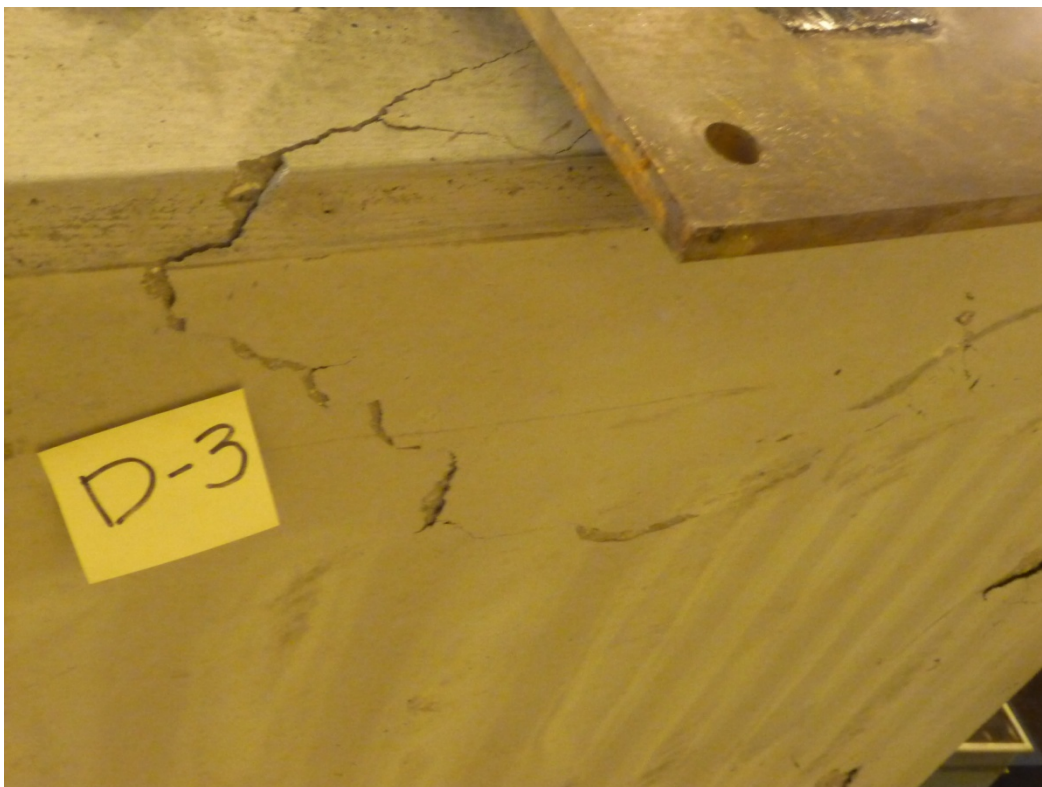
Figure 68 – Test D-3 Failure Mode – bottom side view
