The JVI VC4 Vector Connector Compiled Test Reports

Testing of the JVI Mid V in 4" Slabs

Additional Testing of the JVI Mid V in 4" Slabs

Testing of the JVI Vector Connector 4 in 4" Slabs

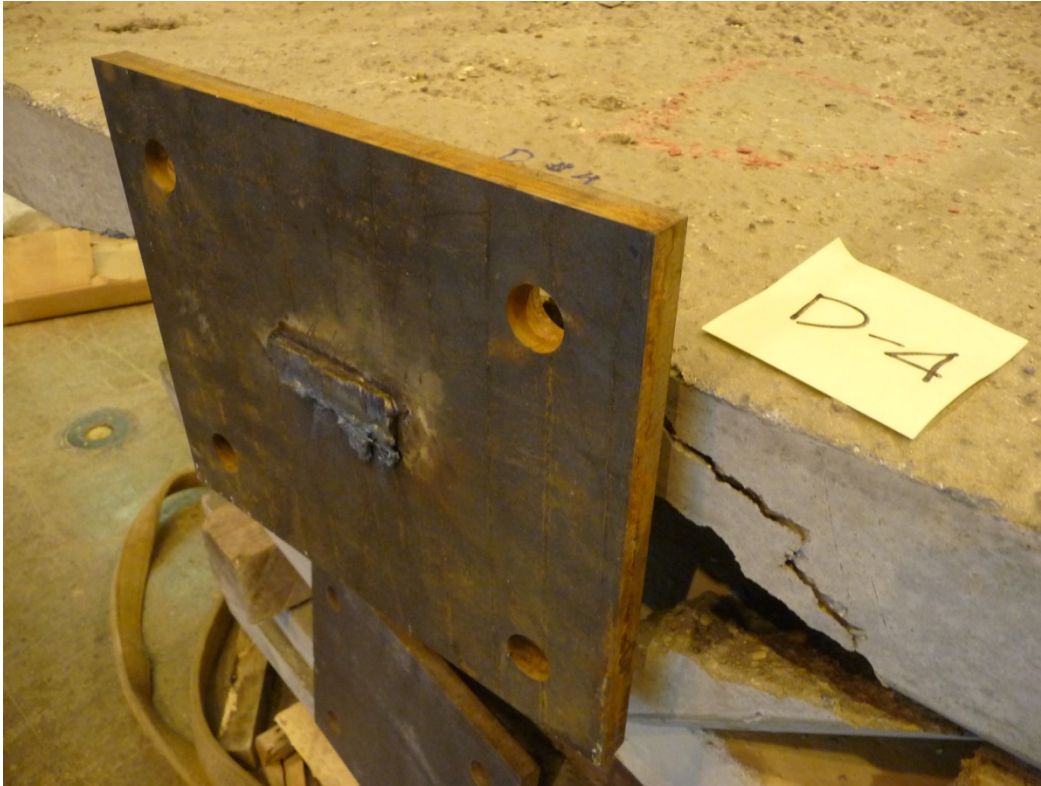
Figure 69 – Test D-4 Failure Mode – top side view

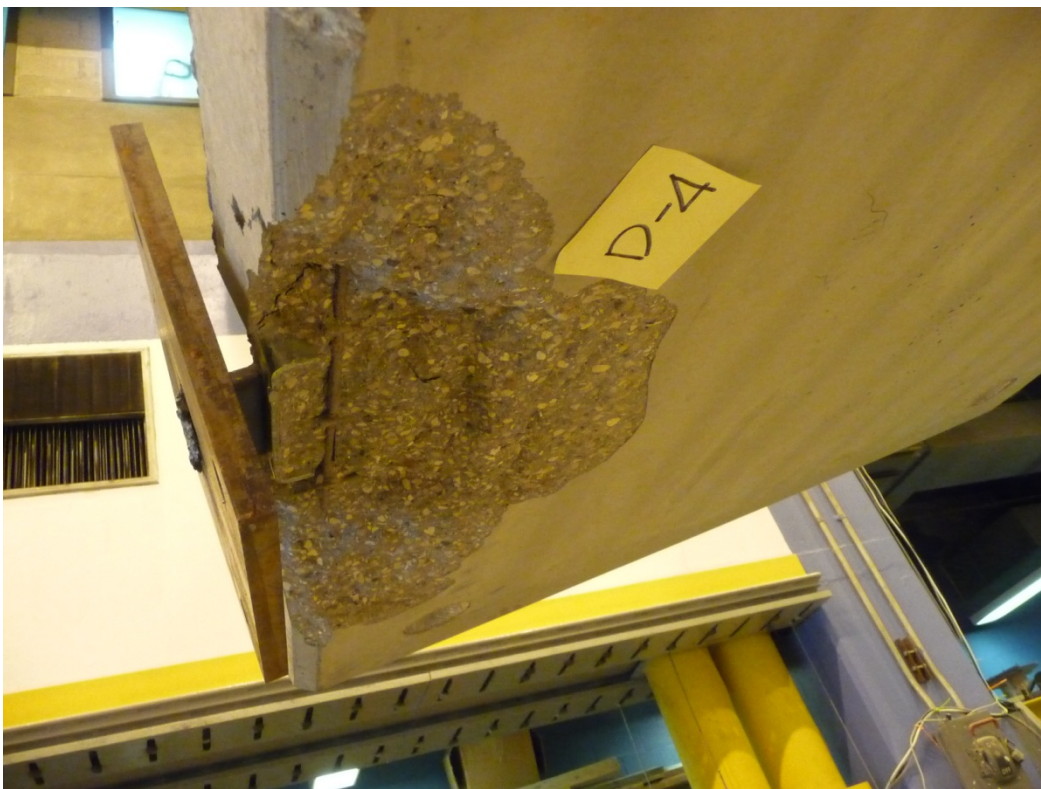
Figure 70 – Test D-4 Failure Mode – bottom side view

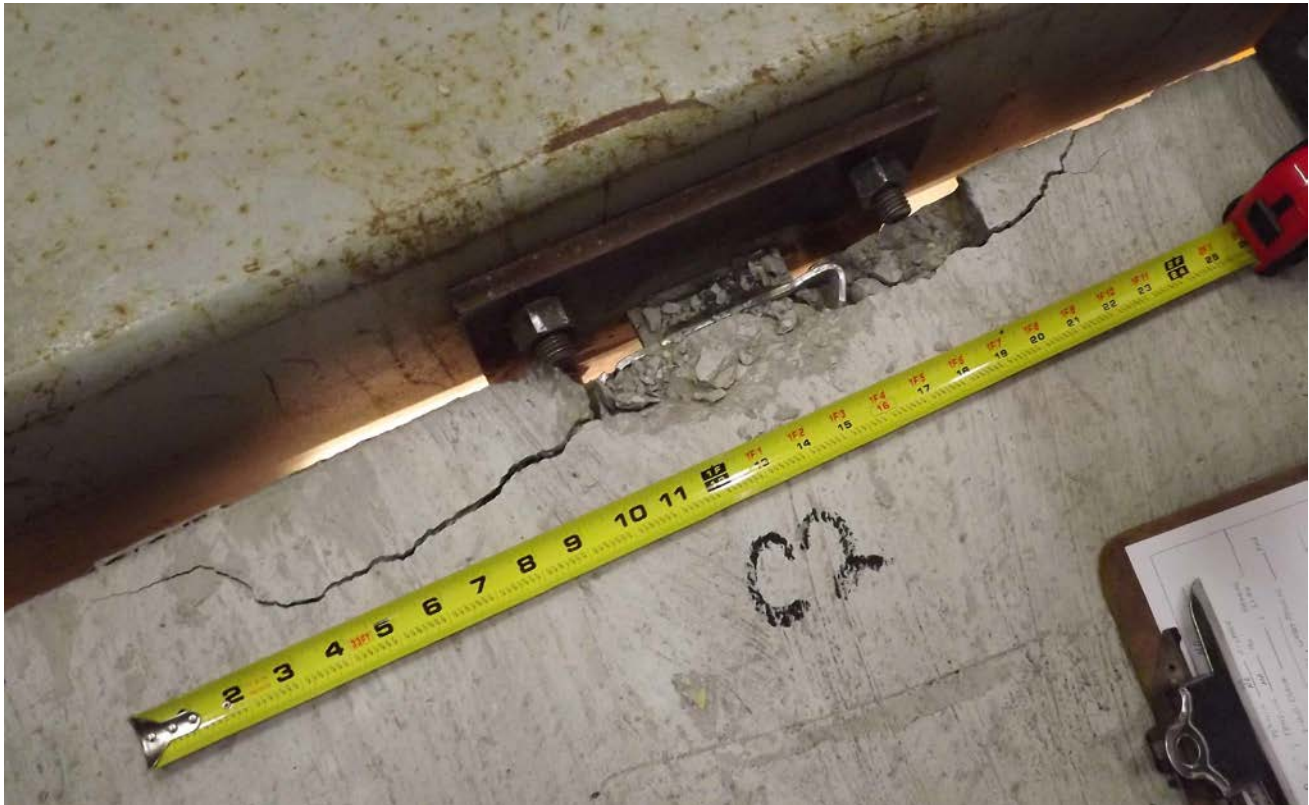
Figure 12 – Test C-2 Cyclic Shear w/ No Tension

A4	11/29/12	N & S	18,472	NA	NA	NA	0.685", S 3rd cycle	Steel failure thru gusset on tension leg
Cyclic Shear with No Tension, VC4 with NO Gusset in corner, 1" Blockout, Type 201L Stainless Steel (Load 12,225# N/S, (3) N/S @ 0.137", (3) @ 0.274", (3) @ 0.411", (3) @ 0.685", (3) @ 1.096" until failure)								
C1	11/30/12	N & S	20,065	NA	NA	NA	1.096", N 1st cycle	Steel failure thru 1st faceplate corner bend on tension side
C2	11/30/12	N & S	19,983	NA	NA	NA	0.685", N 1st cycle	Steel failure thru 1st faceplate corner bend on tension side. Failed sooner than test C1 because concrete remained around 2nd leg corner bend which added stiffness to 2nd bend and thus made 1st corner bend work more and take most of the displacement loads.
D1	11/30/12	N & S	19,502	NA	NA	NA	1.096", N 1st cycle	Steel failure thru 1st faceplate corner bend on tension side
D3	11/30/12	N & S	19,218	NA	NA	NA	0.685", S 2nd cycle	Steel failure thru 1st faceplate corner bend on tension side. Similar issues as defined in Test C2 but with a smaller amount of concrete remaining around 2nd bend.
