# The JVI Mini-V

## Compiled Test Reports

# **Load Tests on “Mini-V” Connector Anchored in 4” Concrete Slabs**

# **Shear Load Tests on JVI “Mini-V” Connector Anchored in 8” Spancrete Hollow Core Slabs**

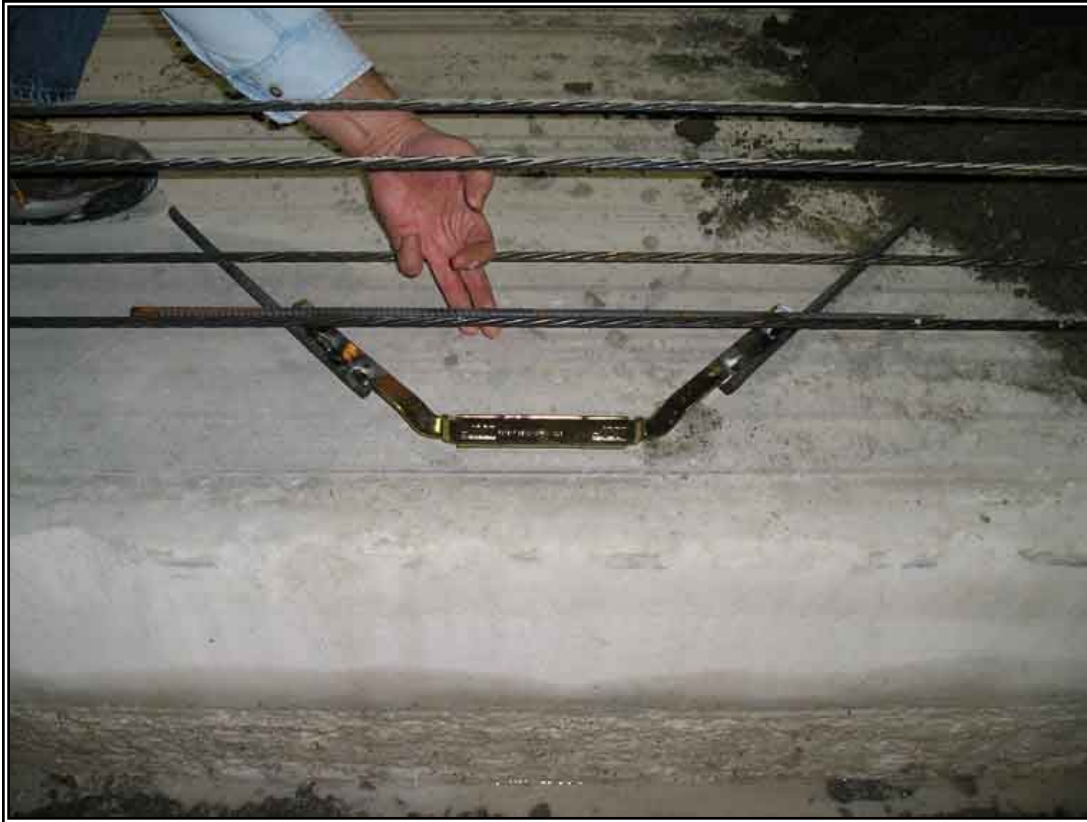
Figure 6: Placement of connector with 3 extra rebar prior to casting

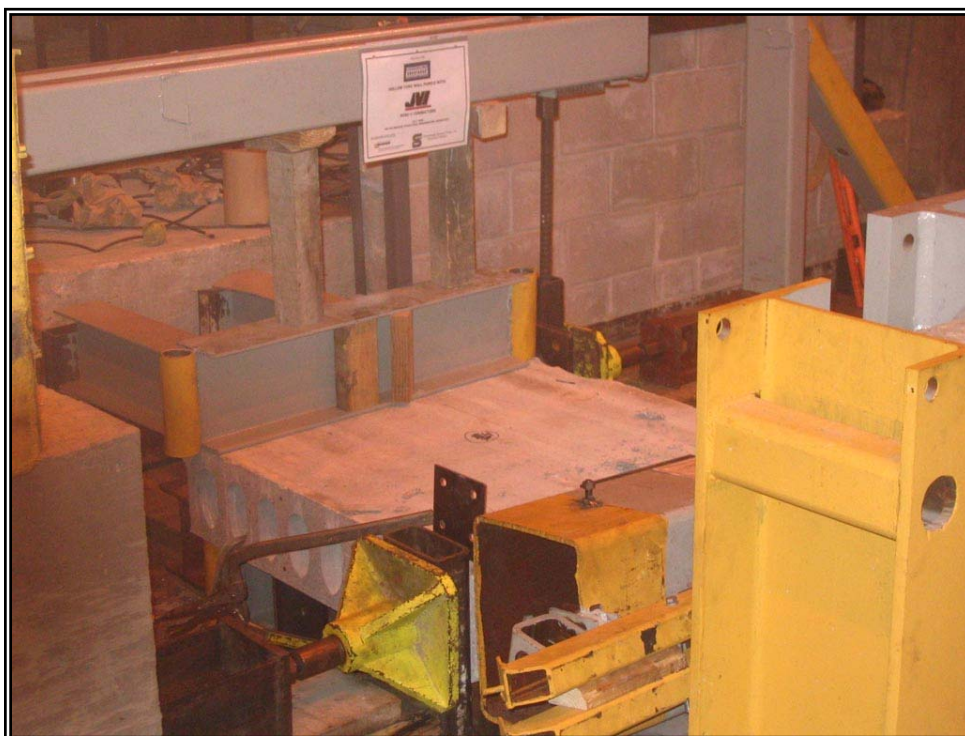
Figure 10: View of test setup

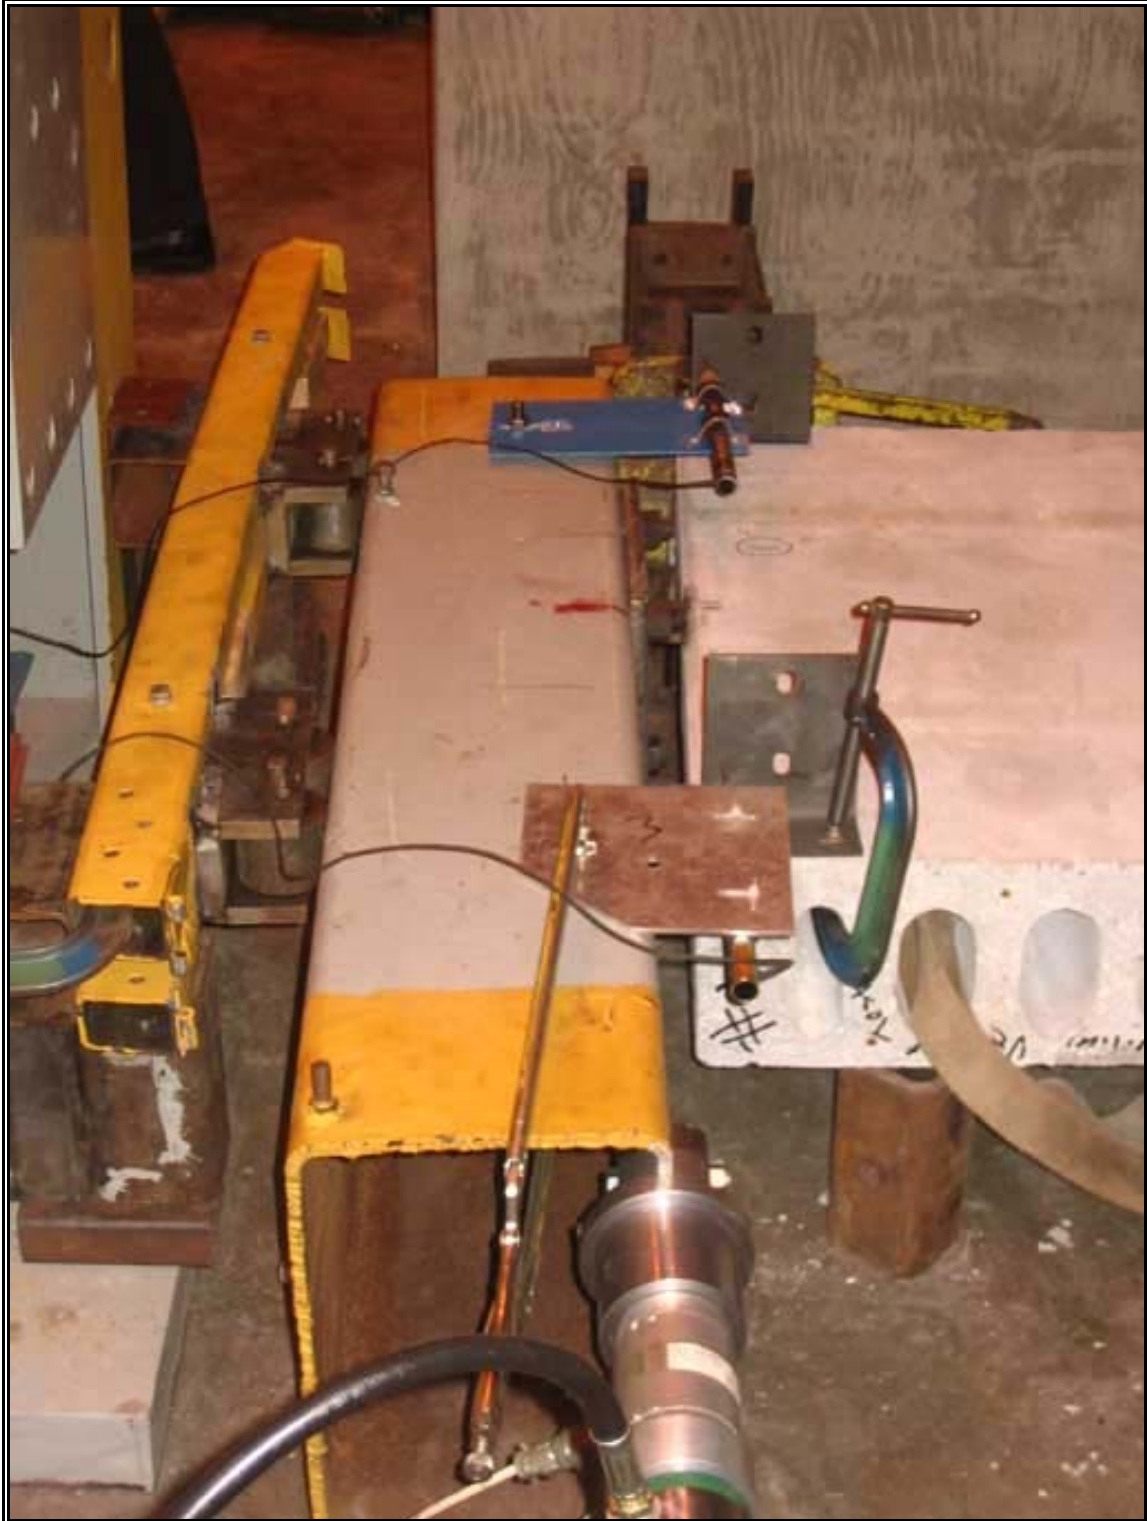
Figure 11: View of test setup. Note average of 2 LVDT readings measure displacement of load beam relative to slab. Also note load cell (bottom, center) engaged between actuator and load beam.

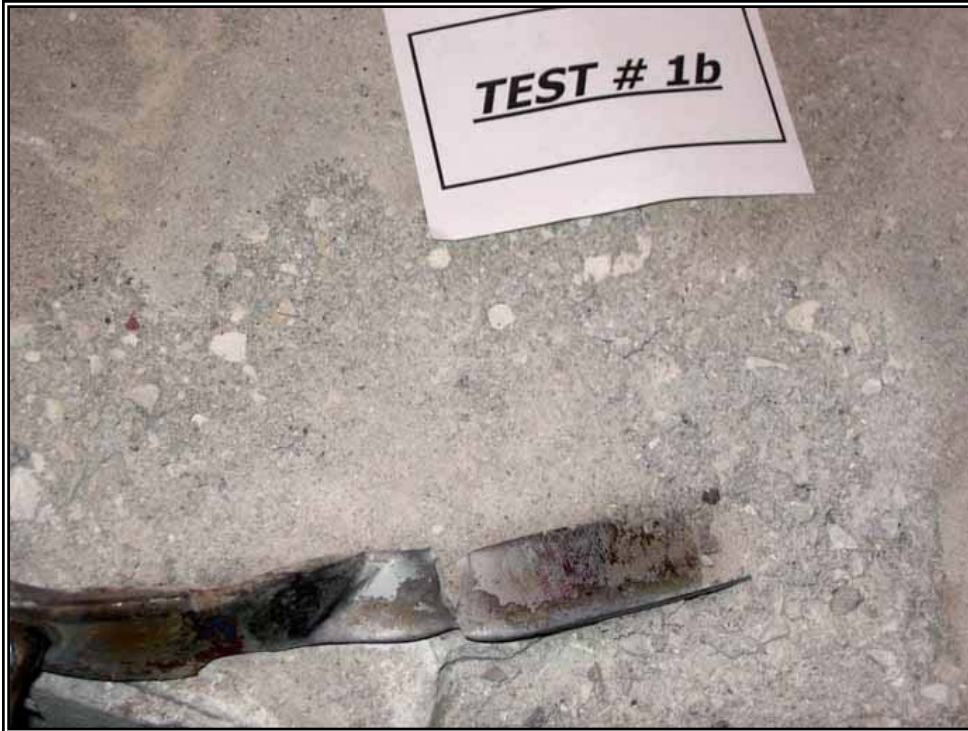
Figure 12: View of typical connector tension leg rupture. Note color of the connector is darkened in this picture to make it stand out from concrete.

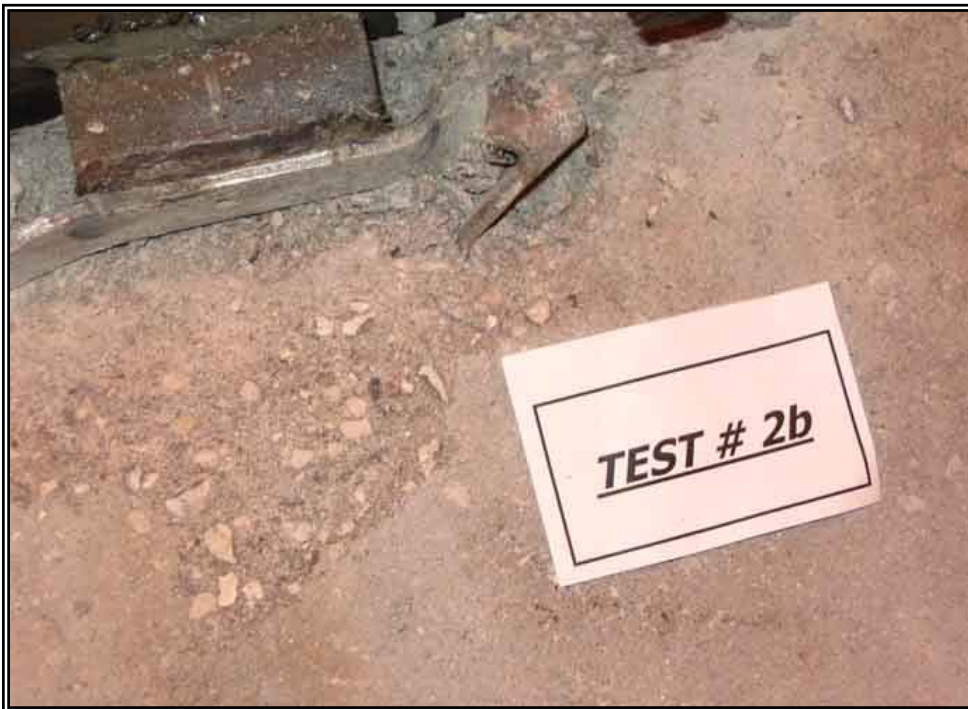
Figure 13: View of typical connector compression elbow buckling.

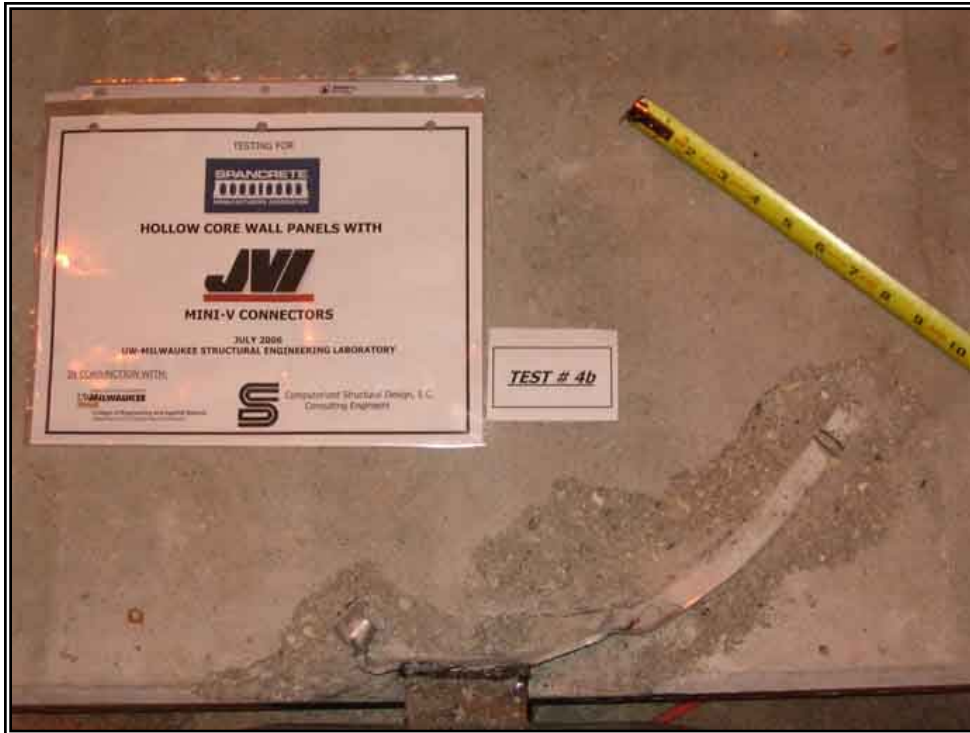
Figure 14: View of typical concrete anchorage failure on connector tension leg.  
Note load was applied from right to left in this picture.

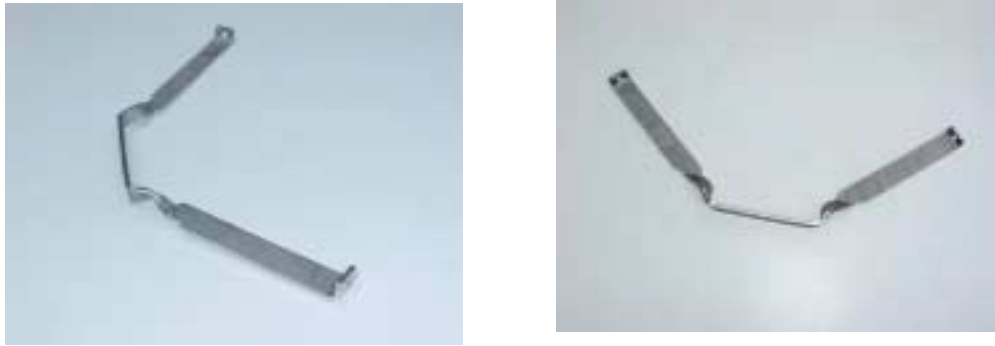
The connectors (Figure 1) were designed, fabricated, and supplied by JVI. Similar shapes were used for both carbon and stainless steel units. When placed in the 2" thick concrete slabs for testing (with 2" of added topping), the connectors were positioned with the flat welding face exposed at the edge of the flange. The connectors in the test specimens were often slightly mis-aligned, slanted from horizontal by as much as 1/8" as might be typical in production conditions.

*Figure 1: Two views of the mini-V connector.*

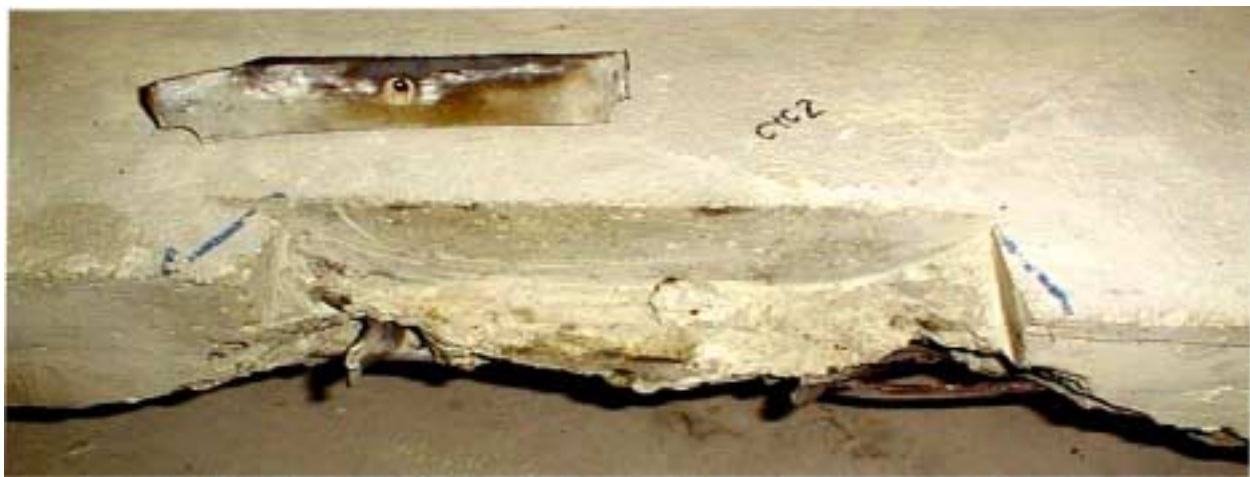
*Figure 8. Condition of concrete surrounding the connector after completion of cyclic test #2.*

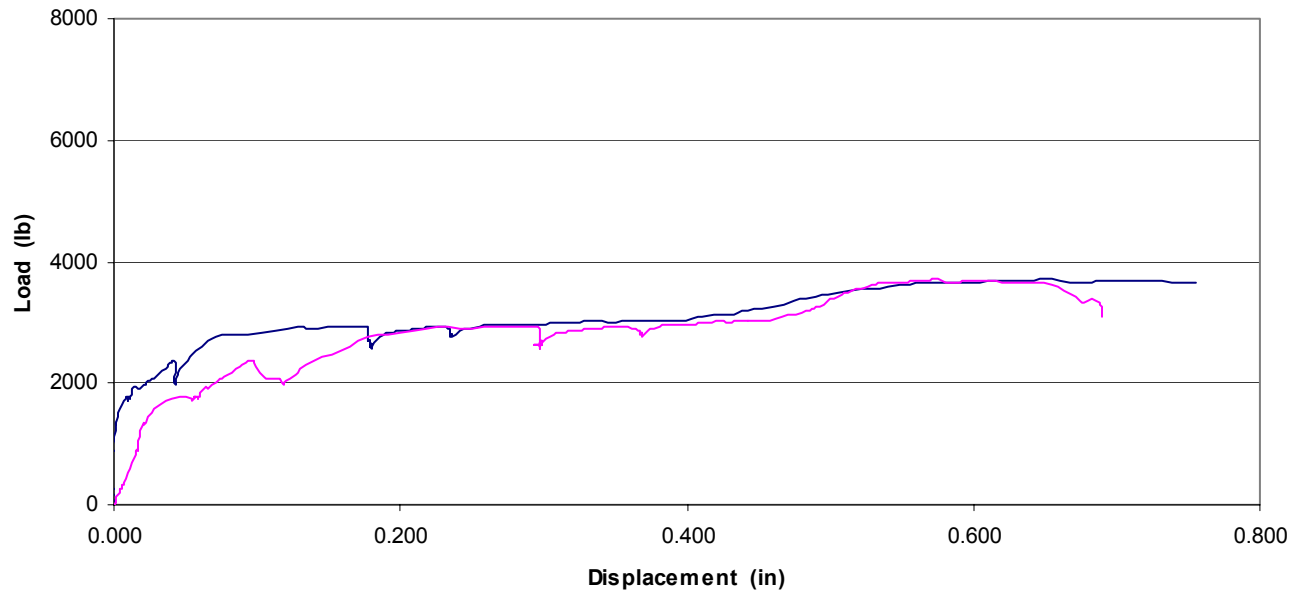
**Test 21 - Vertical Shear- 2-inch slab - J-J-R**

Test Number	Slab Description*	Cracking Load (lb)	Maximum Load (lb)	Failure Mechanism
Vertical Shear	Test 21***	J-J-R	2,937	3,703	spalling of bottom surface
